Town of North Reading – Peter and Anthony Rd Construction-Tree Evaluation

Peter & Anthony Rd North Reading, MA 01864

June 24, 2019

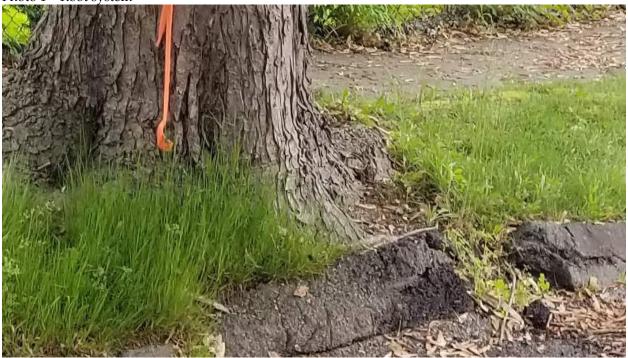
Photo 1 - Root system

All twenty-one (21) trees planted in the small grass strip between the street and sidewalks have a root system that is limited to a very small area. As a result many of the roots have grown right up against the curbing and the sidewalk (see photo 1 pg. 8). Additionally, many of the roots have cracked and raised the sidewalk was well (see photo 2 pg. 8). The eighteen (18) trees behind the sidewalk are close the

It is my recommendation, based the evidence collected as well as my education and many years of experience that all thirty-nine (39) trees in the Peter & Anthony Rds. Project be removed before construction begins. This will mitigate the risk of potential hazards in the future as well as prevent need for future maintenance and removal of dead and dying trees after the project is completed.

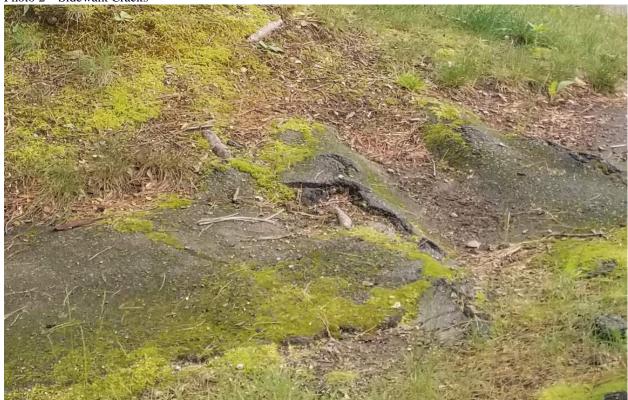
Photo 2 – Sidewalk Cracks

sidewalk and display similar impact on the existing sidewalk, raised and cracked. In addition to the impact along the sidewalk several trees exhibited sign of potential risk; decay, broken and damaged branches as well as heavy leans (see photos 3, 4 & 5 pgs. 9-10).
