Eisenhaures Pond Park Natural Resource Inventory and Conceptual Trail Plan

Prepared for the Town of North Reading Land Utilization Committee

**by Elizabeth B. Newlands
Mass Audubon Ecological Extension Service**

January 2012

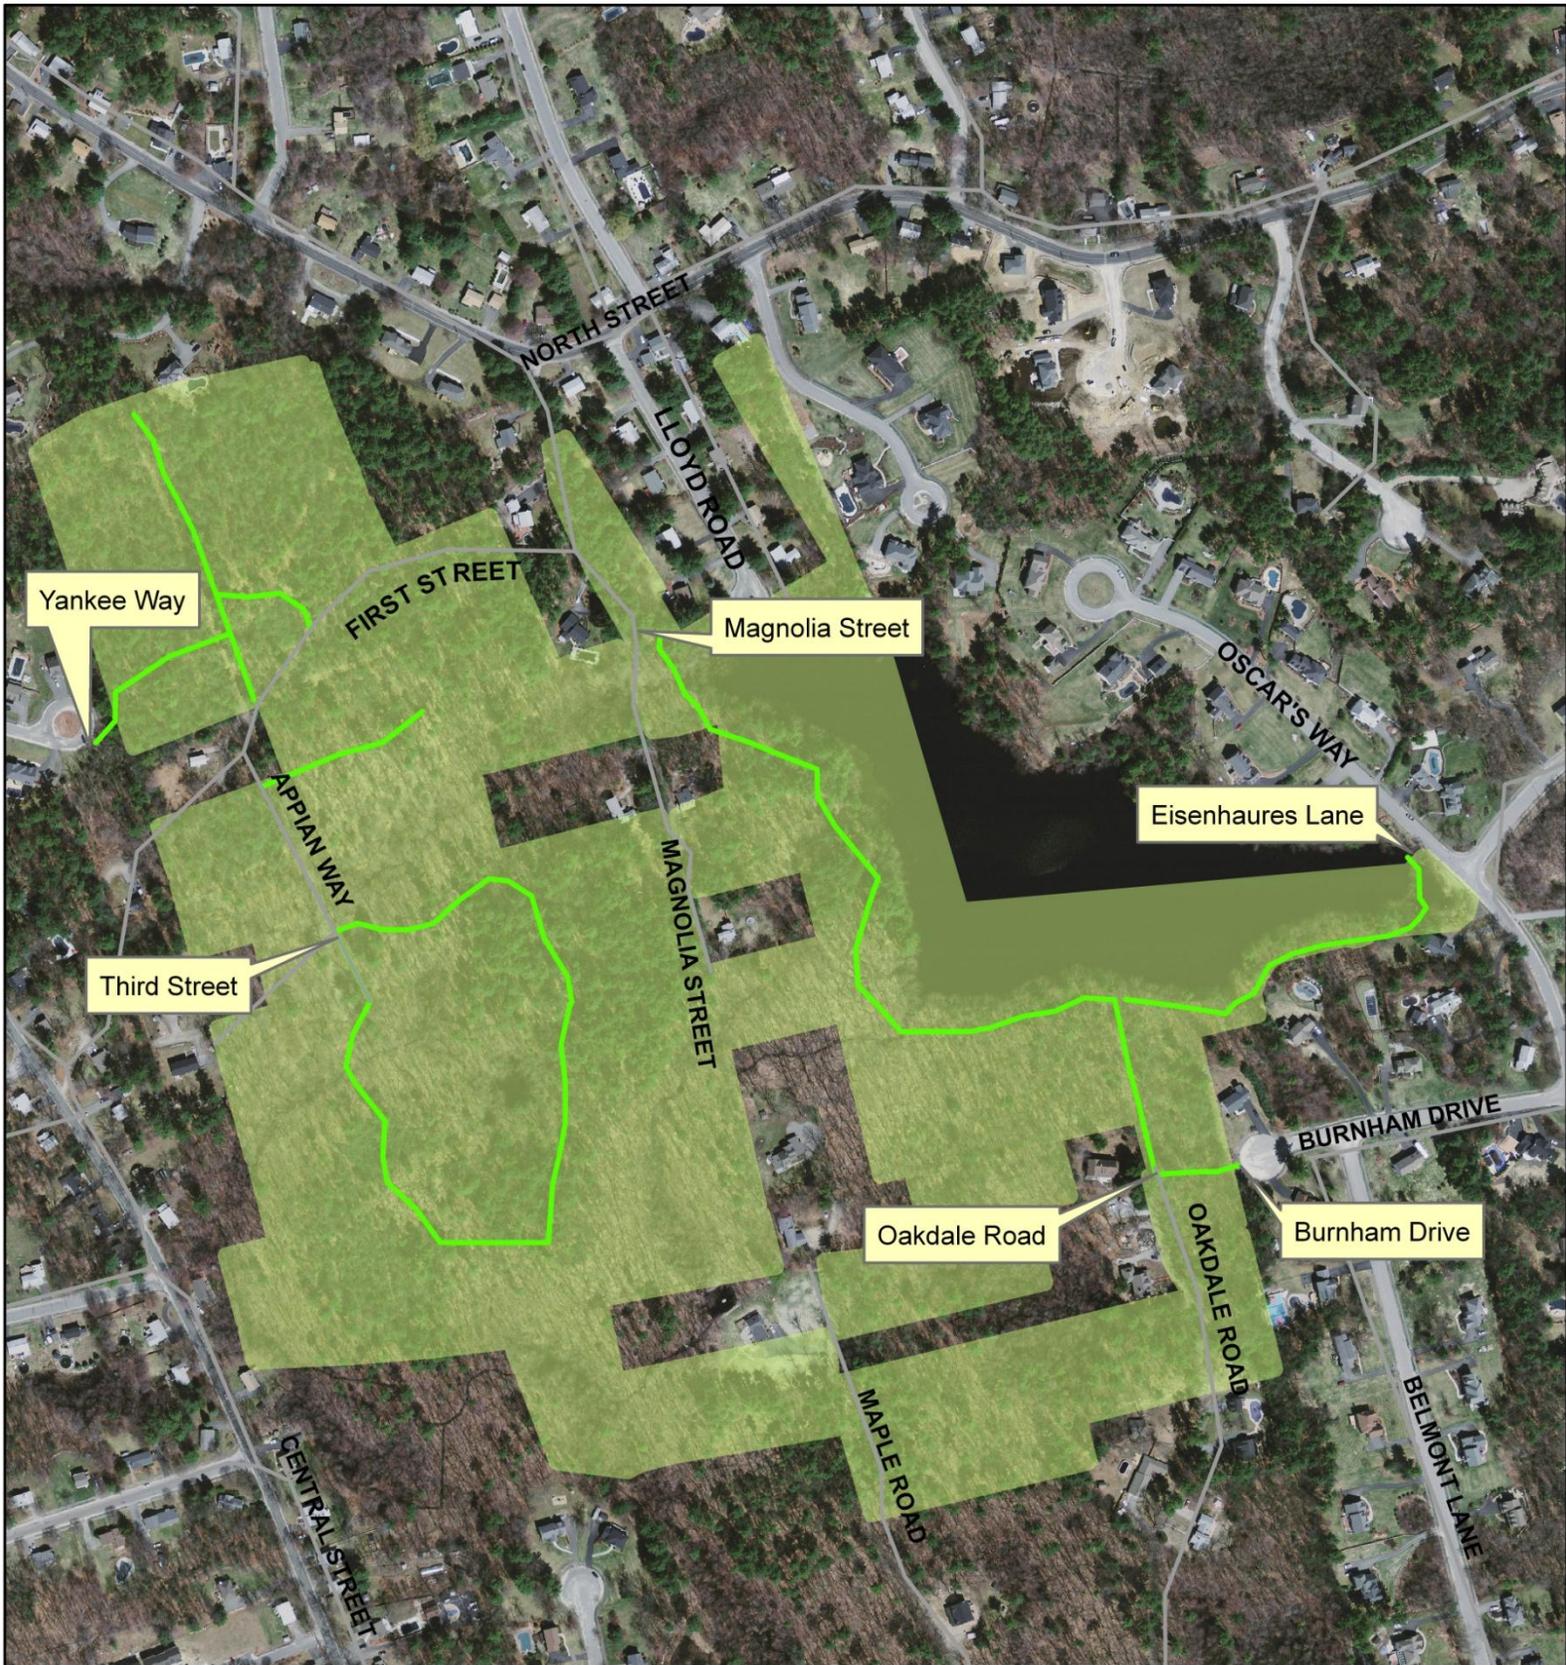
Figure 4. Eisenhaures Pond Park

Existing Trails and Entrances

Residential development on the perimeter of the park and the in-holdings within the park limit public access to the property. Currently, there are six entrances (Figure 4). Two of the entrances are located off North Street: one off Magnolia Street and another at the corner of Appian Way. A third entrance lies at the end of Eisenhaure Lane (near the intersection with Oscar's Way), and a fourth nearby off Burnham Drive. Another entrance near Burnham Drive is located at the end of Oakdale Road. The sixth entrance is located at the end of Yankee Way, in the northeast corner of the park.

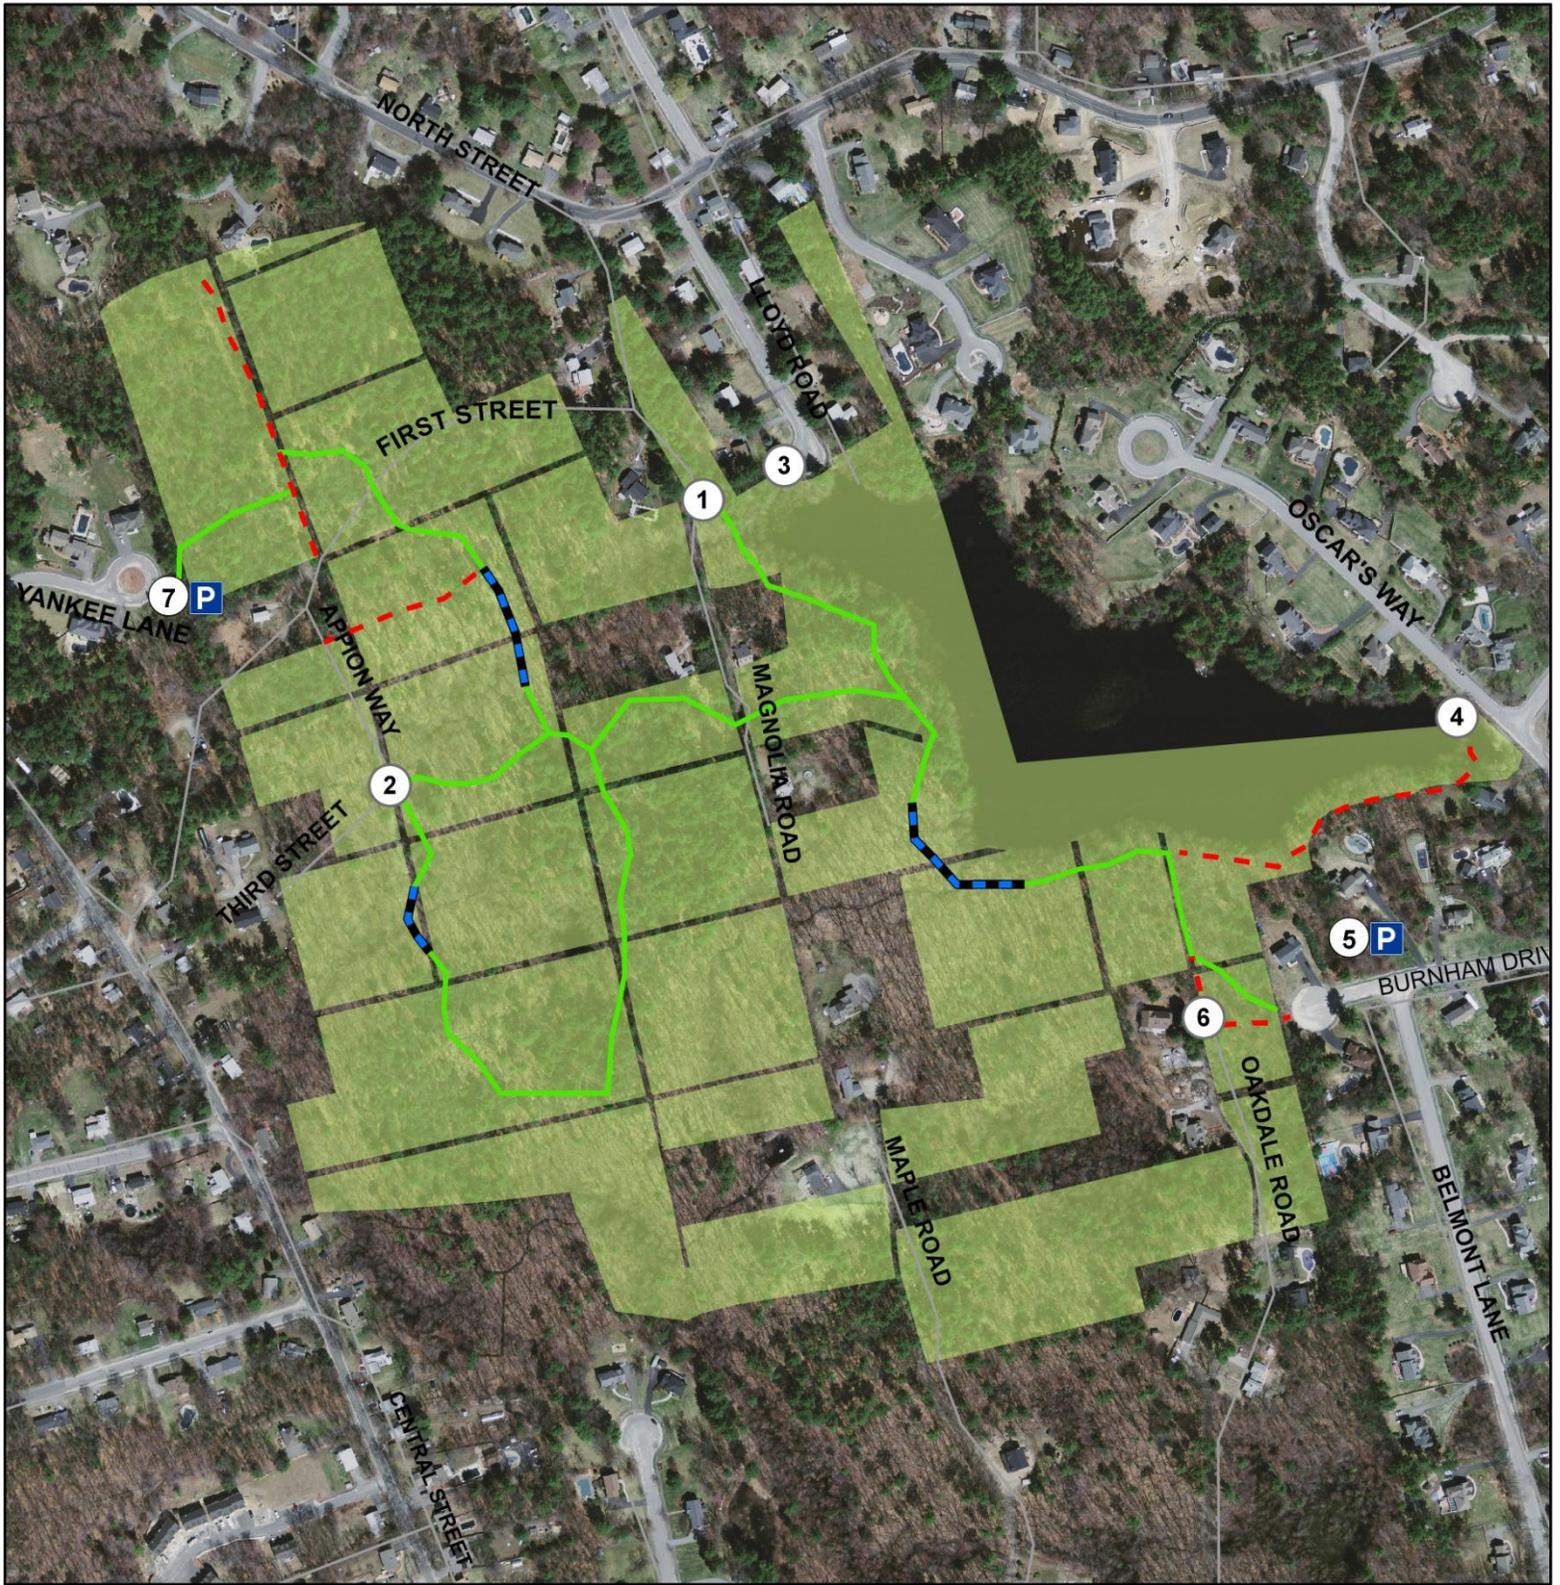
Figure 5. Eisenhaures Pond Park

Conceptual trail plan

- Recommended trail
- — Proposed bog/board walk
- - - Proposed trail closure
- 1 Potential trail head
- P Explore parking expansion
- Roads

After exploring all of the possibilities, which are described in detail below and shown on Figure 5, we recommend Burnham Drive and Yankee Lane be designated as primary access points. This will create eastern and western trail heads at previously existing entrances. Locating trail heads at these two points will also take advantage of small, existing town-owned parcels shown on assessor’s maps. At the same time, locating trail heads at these locations will not stress unimproved roads that would be poorly suited to increased traffic flow. However, we advise the Land Utilization Committee to consult with the Planning Department and Fire Department to ensure proper development of parking spaces in the cul-de-sacs at the end of Burnham Drive and Yankee Lane so that any improvements that fall within safety requirements and all other town regulations and ordinances.

Several existing trails cross wetlands and intermittent streams. These crossings are either on improvised structures (such as pallets laid in the substrate), across stones, or directly through the wetlands at-grade (see photos #16, 26, 29, 47, 48). These crossings are hazardous to visitors or damaging to wetland and aquatic resources. We describe several possible solutions to improving wetland crossings, and depict their locations in the map on Figure 5.

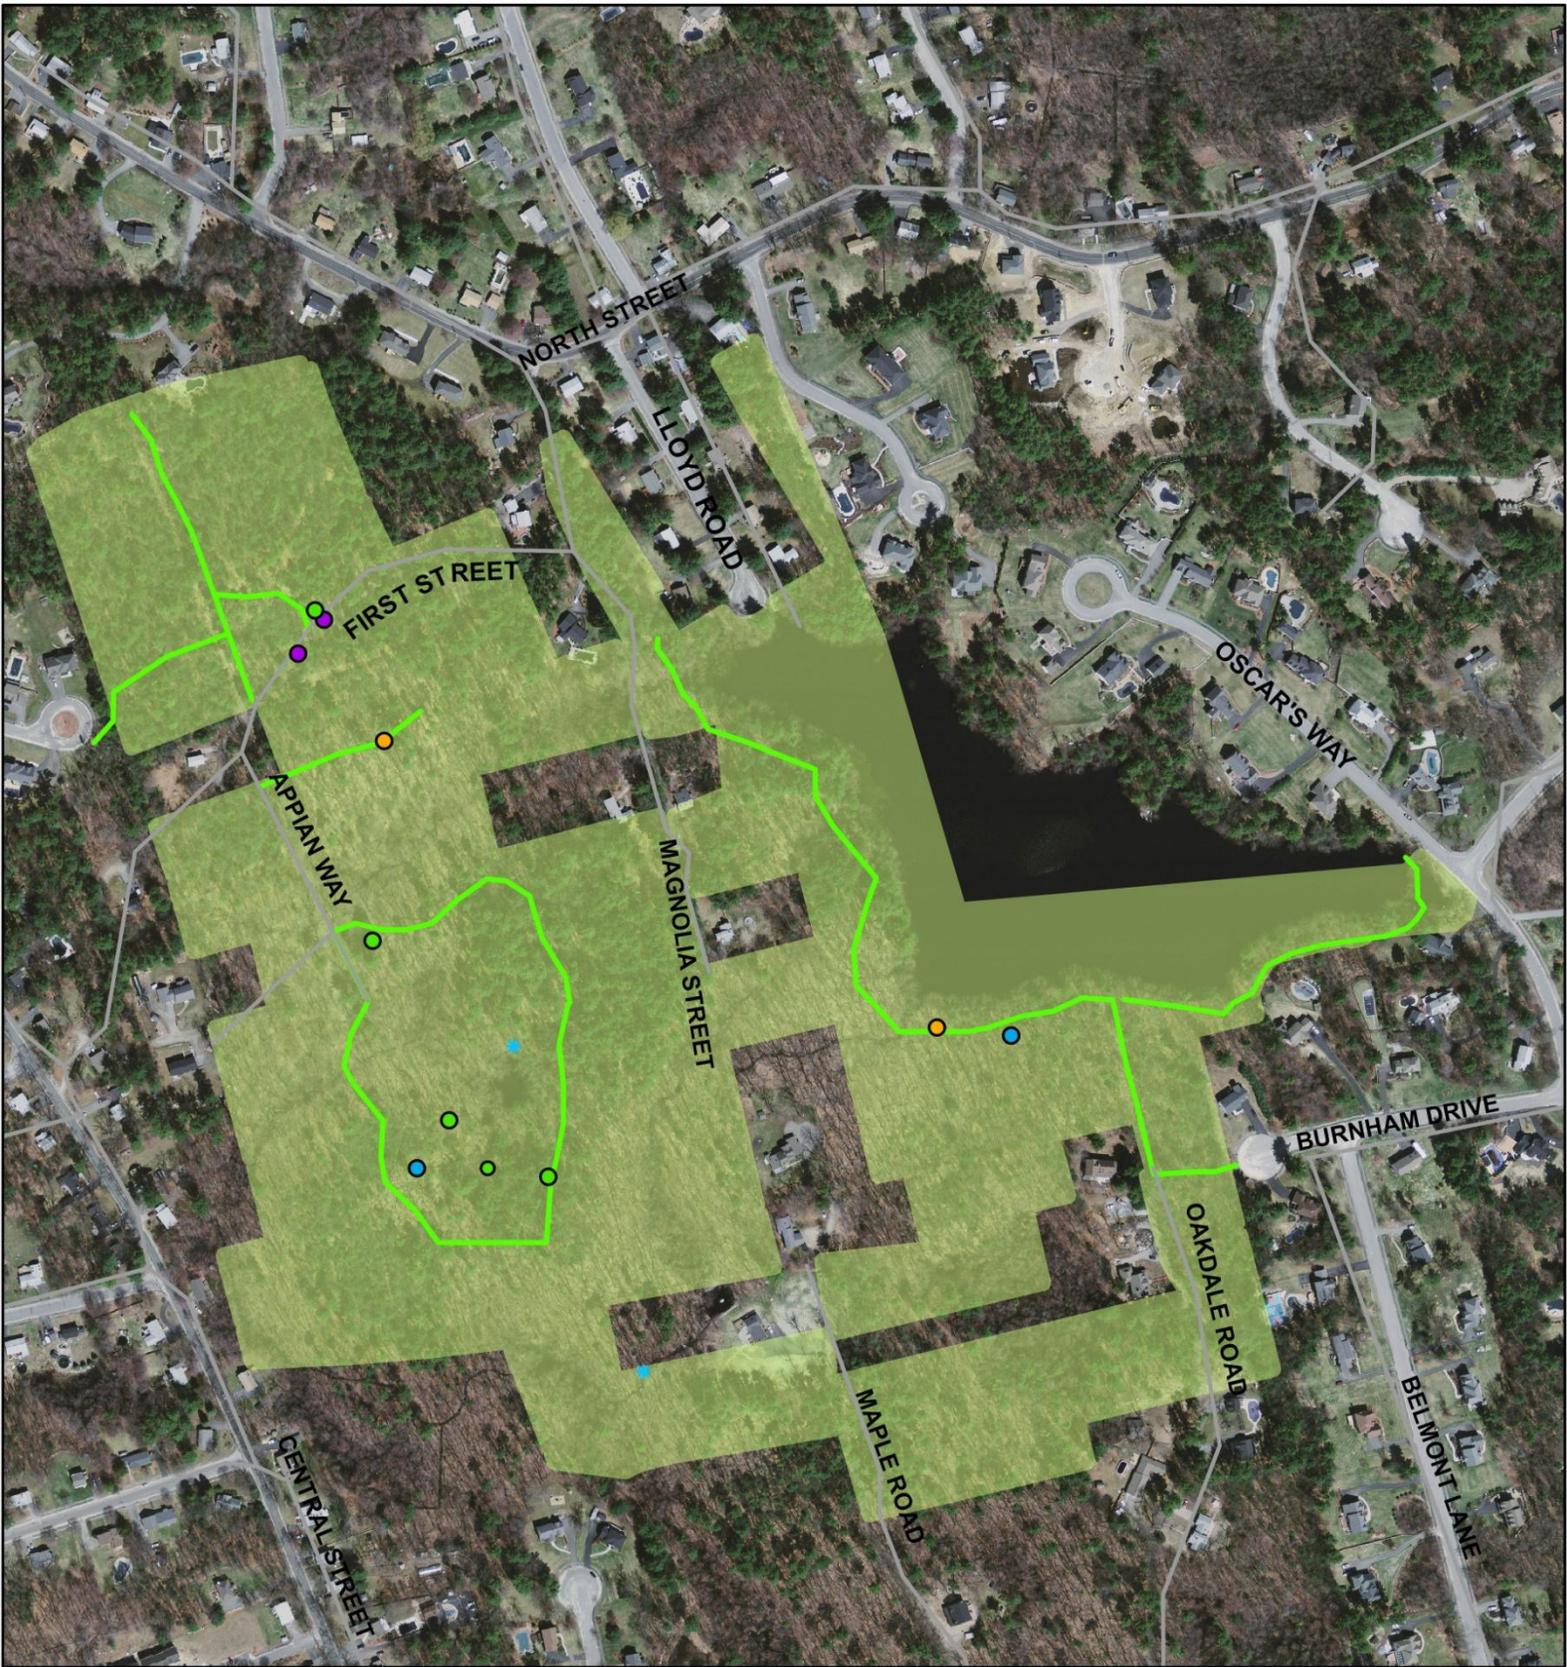
Figure 7. Eisenhaures Pond Park

Monitoring points

During our site visits, we noted several areas that require immediate attention due to the threat to natural resources (Figure 7). These include: dumping spots, forts, ATV use, improvised wetland crossings, and fire circles. These sites are documented with photographs found in the end of this report.

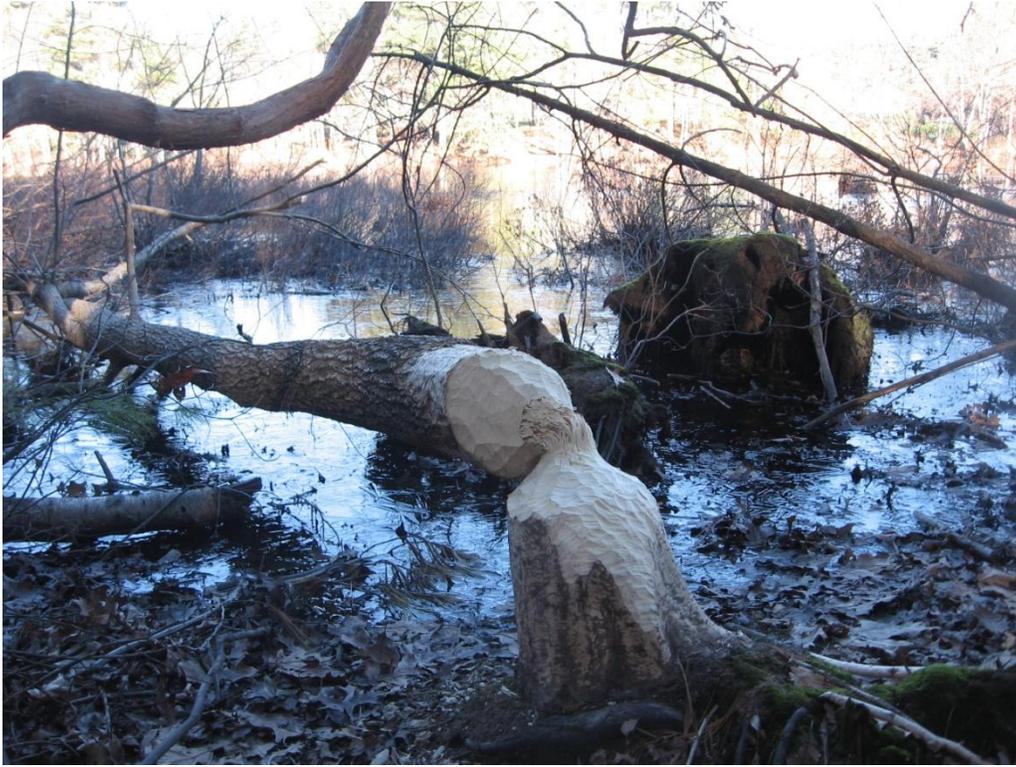
1. Evidence of beaver activity at Eishenhaure Pond Park.

We observed signs of White-tailed Deer and Beaver in the park. Deer scat was observed throughout the property, and chew marks on trees were seen in wetlands along the northwest shore of the pond (photo #1).

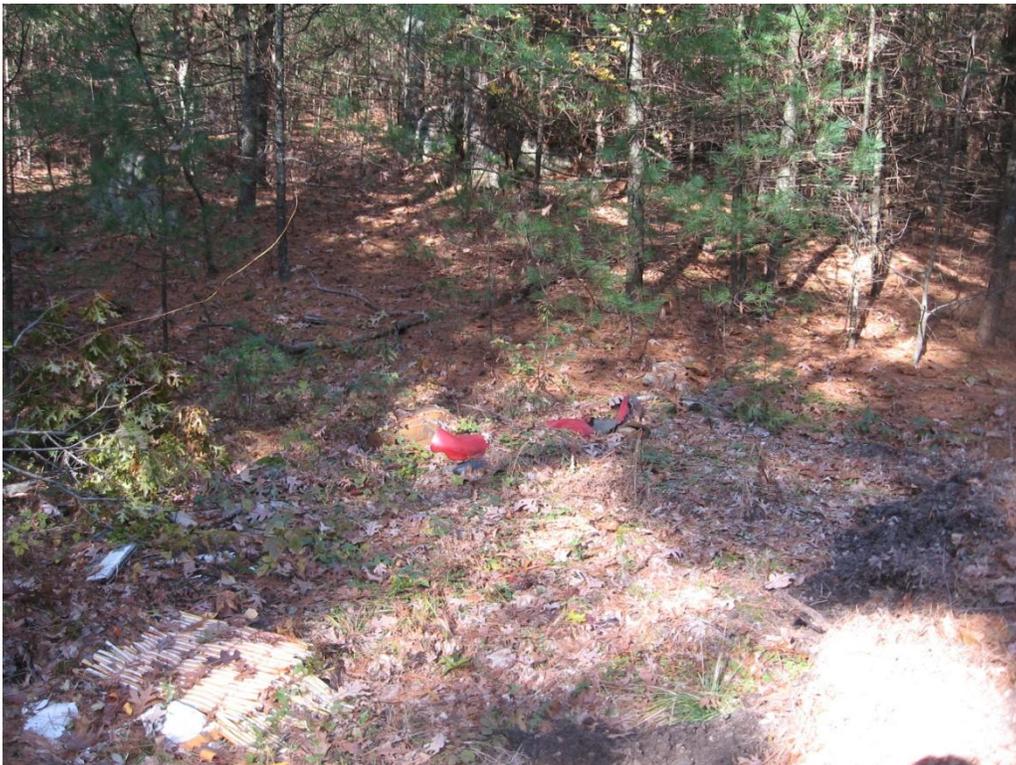
2. Trash in woods off trail along southern margin of pond.

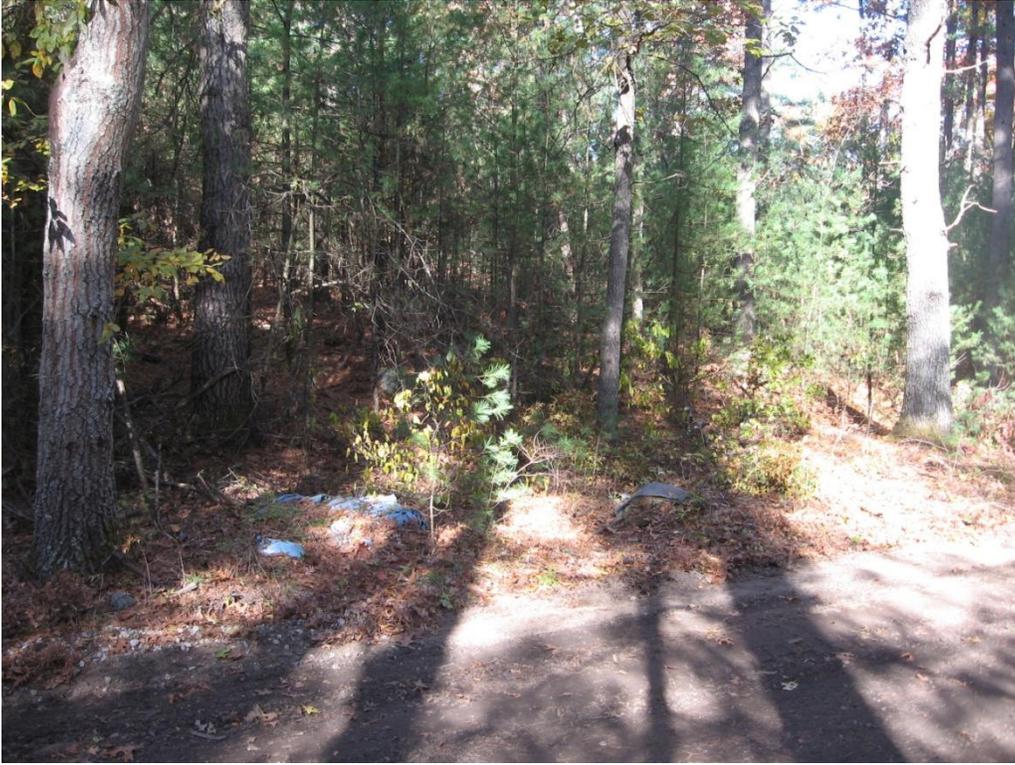
5. Trash dumped along First Street in Eisenhaures Pond Park.

Evidence of recent ATV use was observed throughout the western portion of the park. Illegally dumped materials were found at several locations along dirt roads in the interior of the property. Stone fire rings and make-shift wooden “forts” were also found in several locations on the property. These uses reduce the natural resource values of the property and seem to be inconsistent with the intention of providing users with a nature experience. We recommend that the Land Utilization Committee disassemble the forts, disperse the stone fire rings, and investigate the source of the ATV traffic and educate townspeople about the acceptable uses of the property.

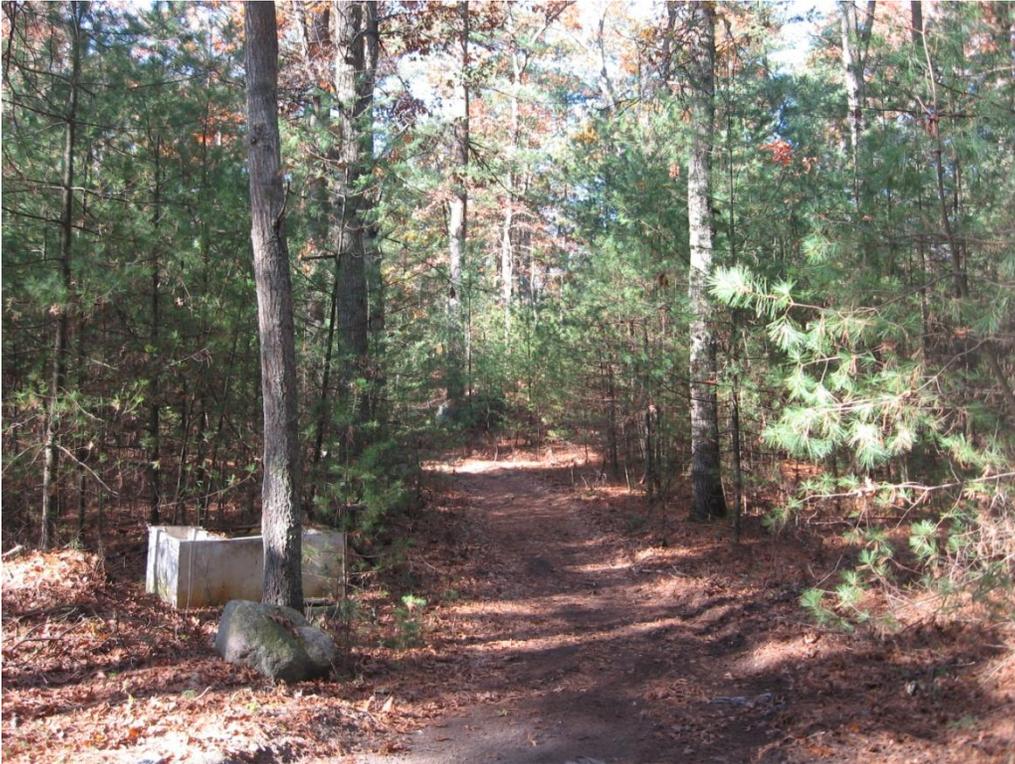
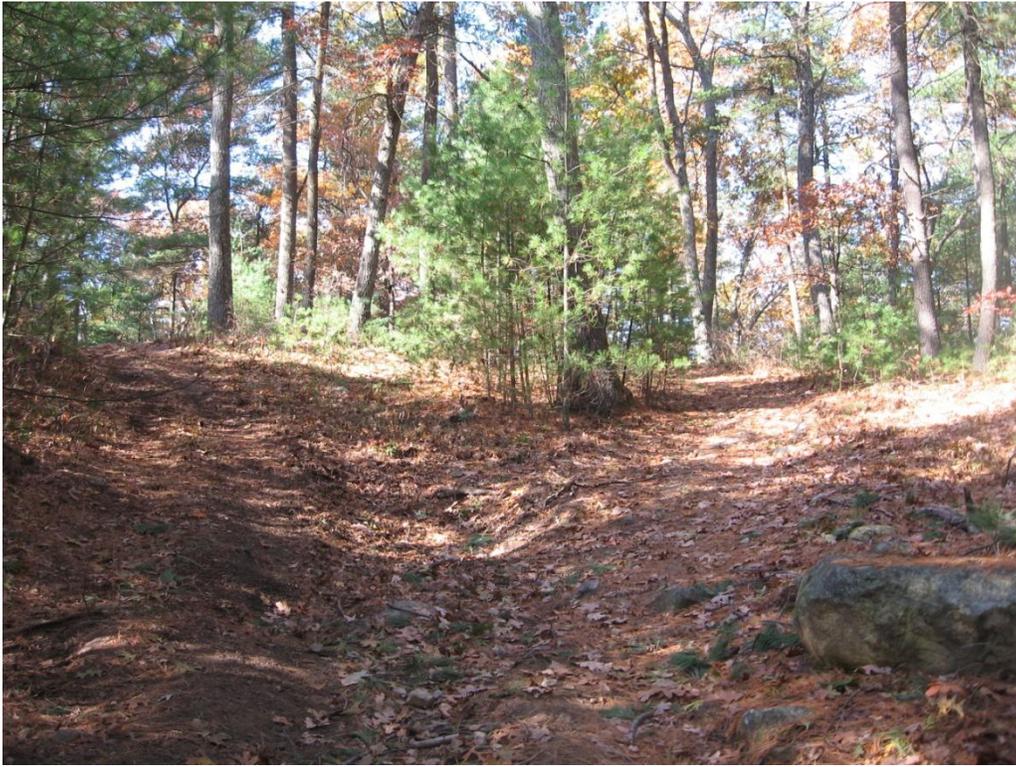
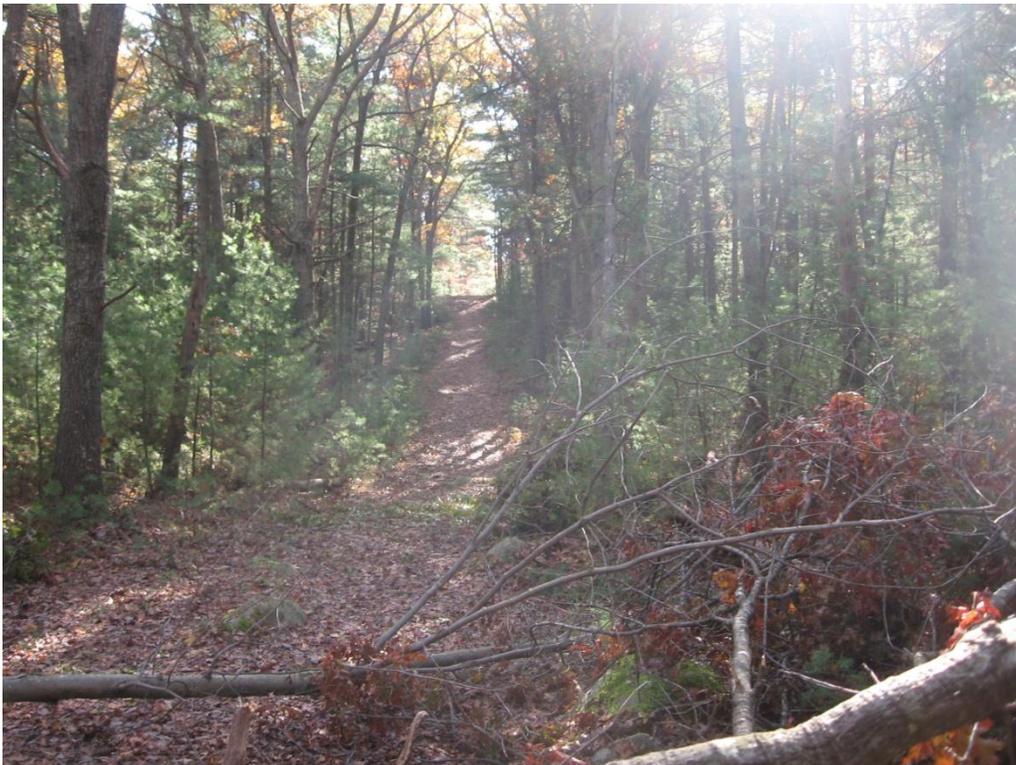
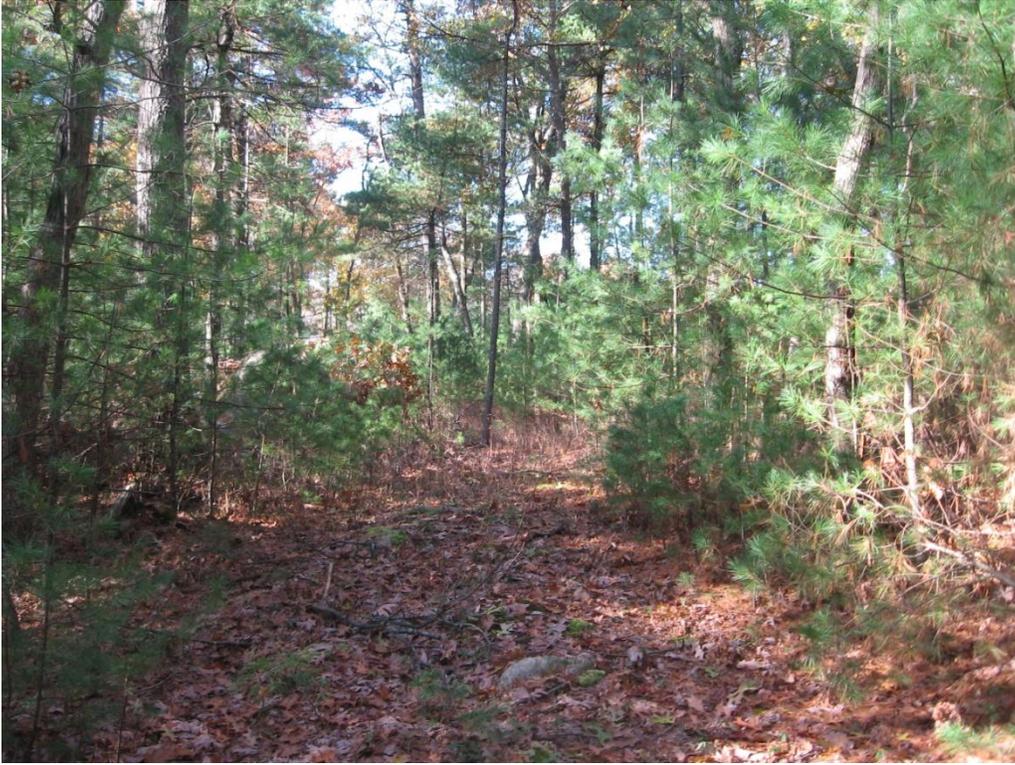
6. ATV trails in Eishenhaures Pond Park off First Street

7. ATV trails in Eishenhaures Pond Park off First Street.

8. ATV trails in Eishenhaures Pond Park off First Street

9. ATV trails in Eishenhaures Pond Park off First Street.

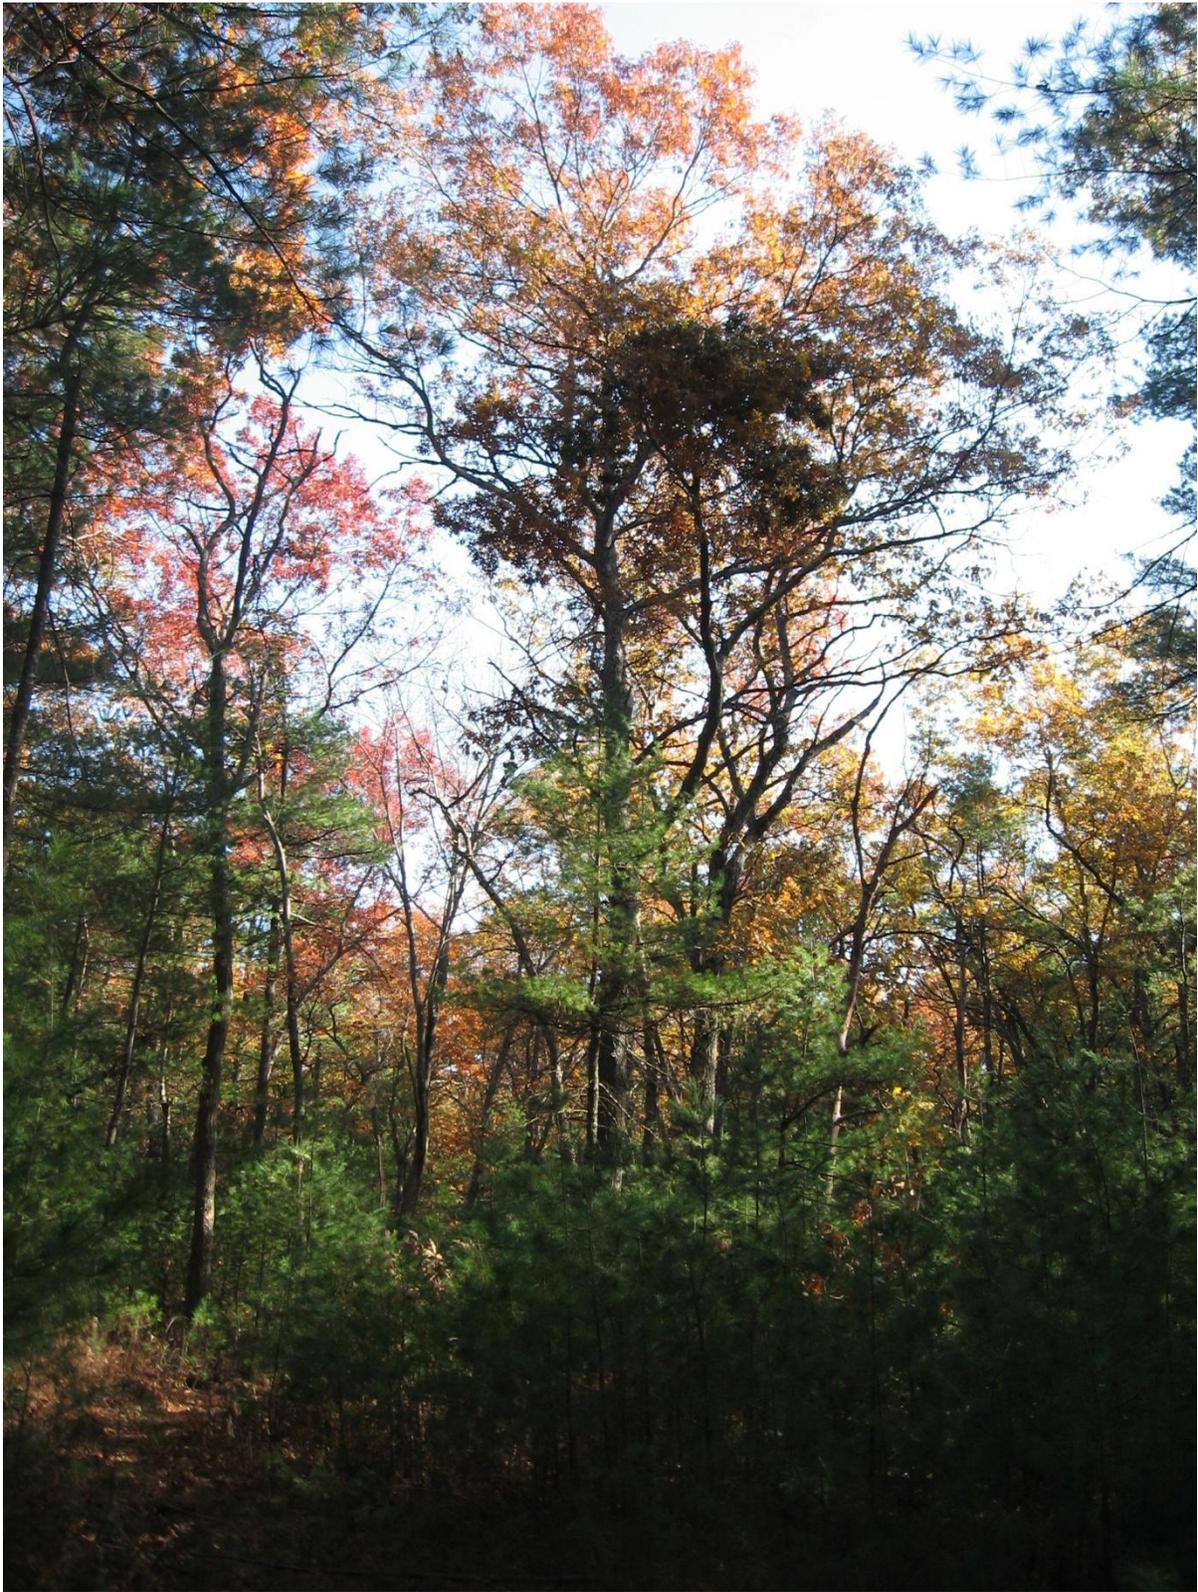
10. Mature oak canopy with significant White pine regeneration in the understory. Thinning the pine will promote a more diverse canopy structure in the future.

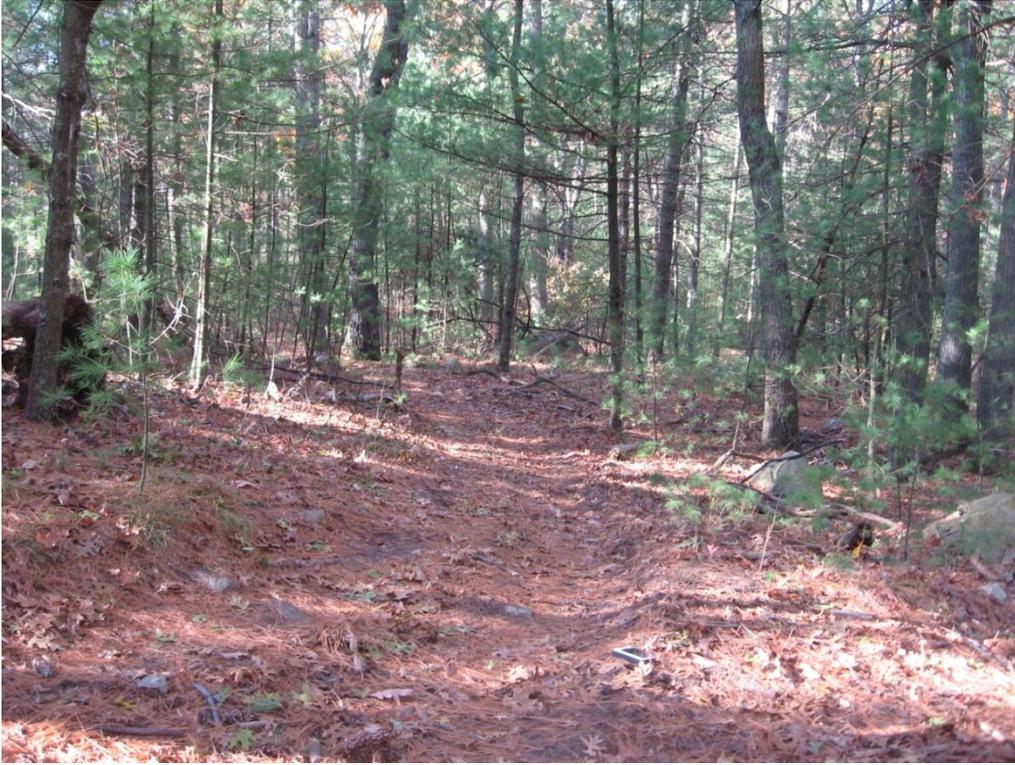
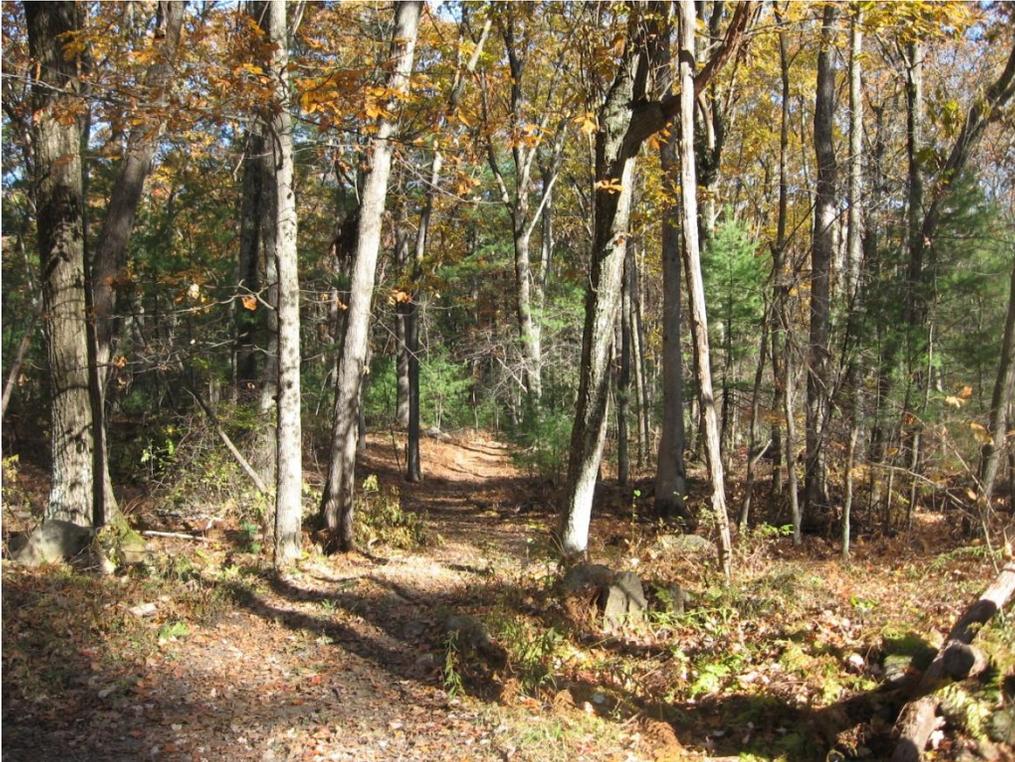
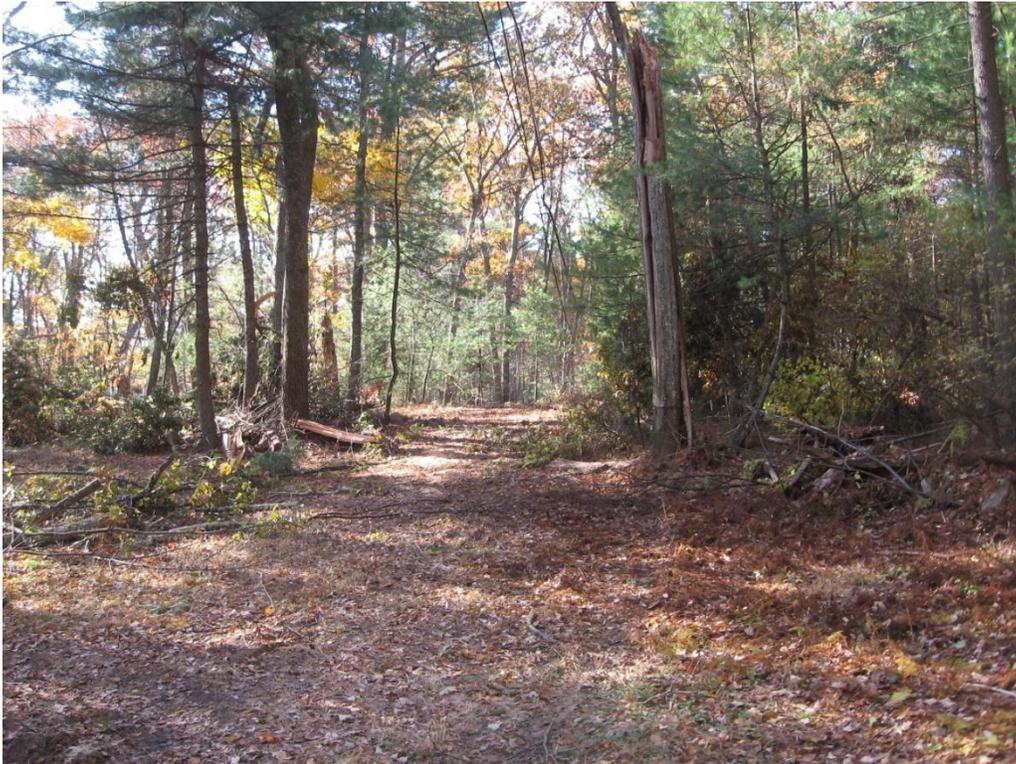
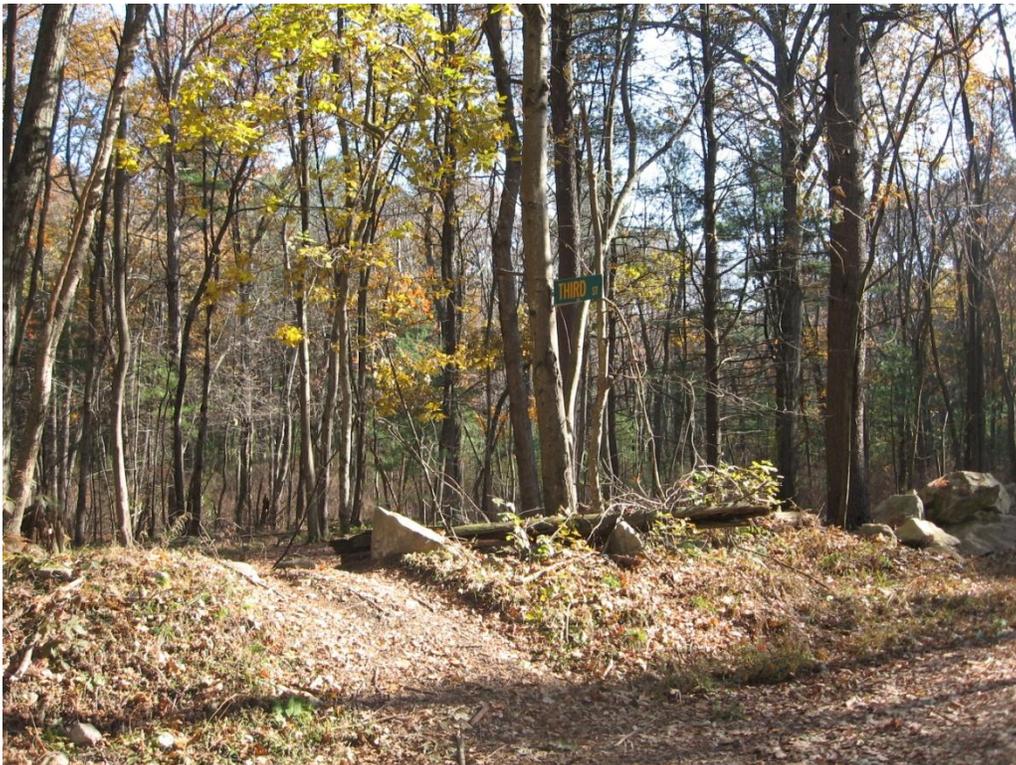
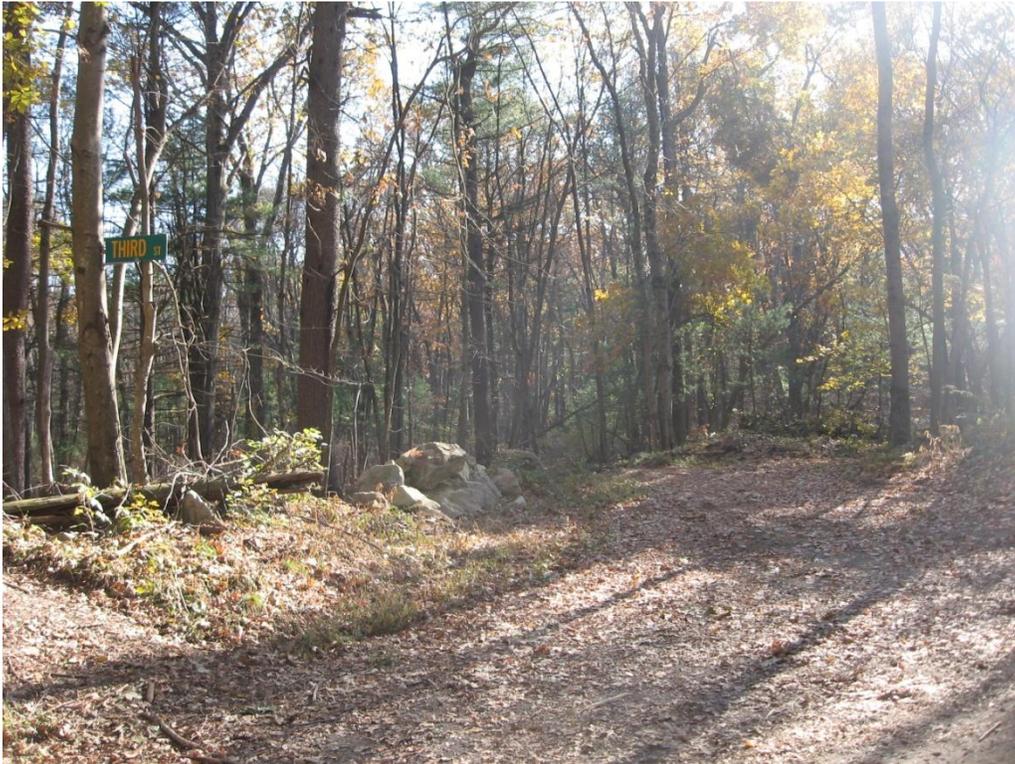
11. ATV trails in Eishenhaures Pond Park off Third Street.

12. ATV trails in Eishenhaures Pond Park off Third Street.

13. ATV trails in Eishenhaures Pond Park off Third Street.

14. ATV trail in Eishenhaure's Pond Park off Third Street.

15. ATV trail in Eishenhaure's Pond Park off Third Street

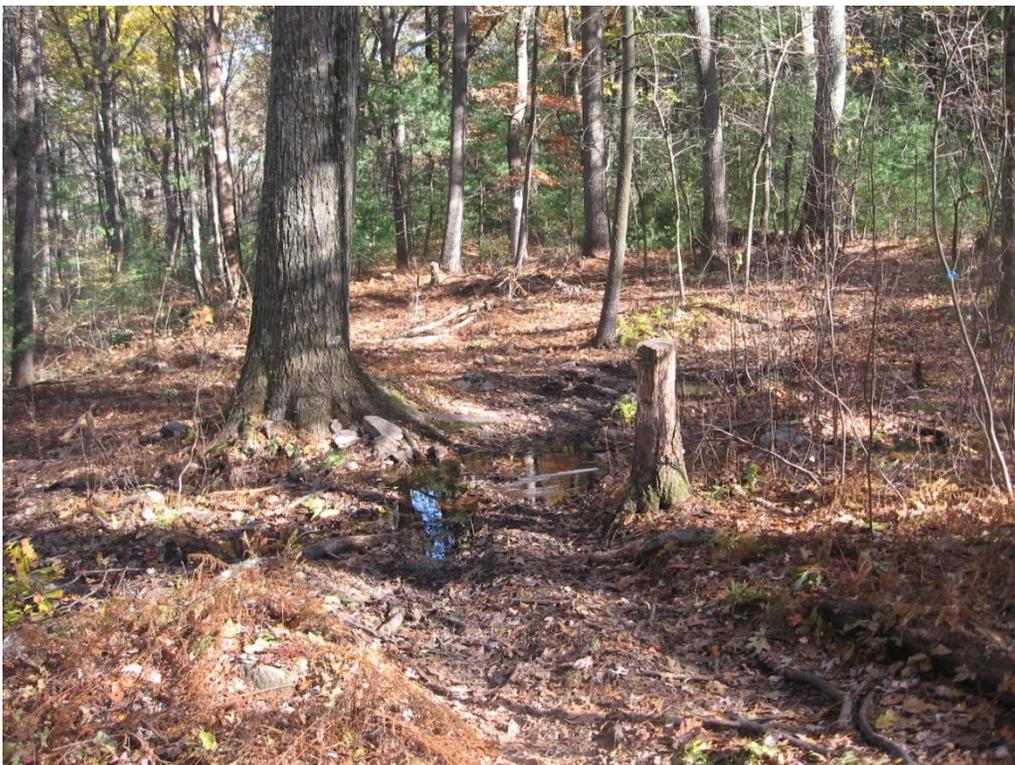
16. ATV trail through wetlands. This type of crossing is damaging to wetland resources.

When trails that cross at-grade through wetlands cannot be located outside of the bordering vegetated wetland, we recommend that they be replaced with a “bogwalk” - boards laid across and affixed to logs set in the ground.

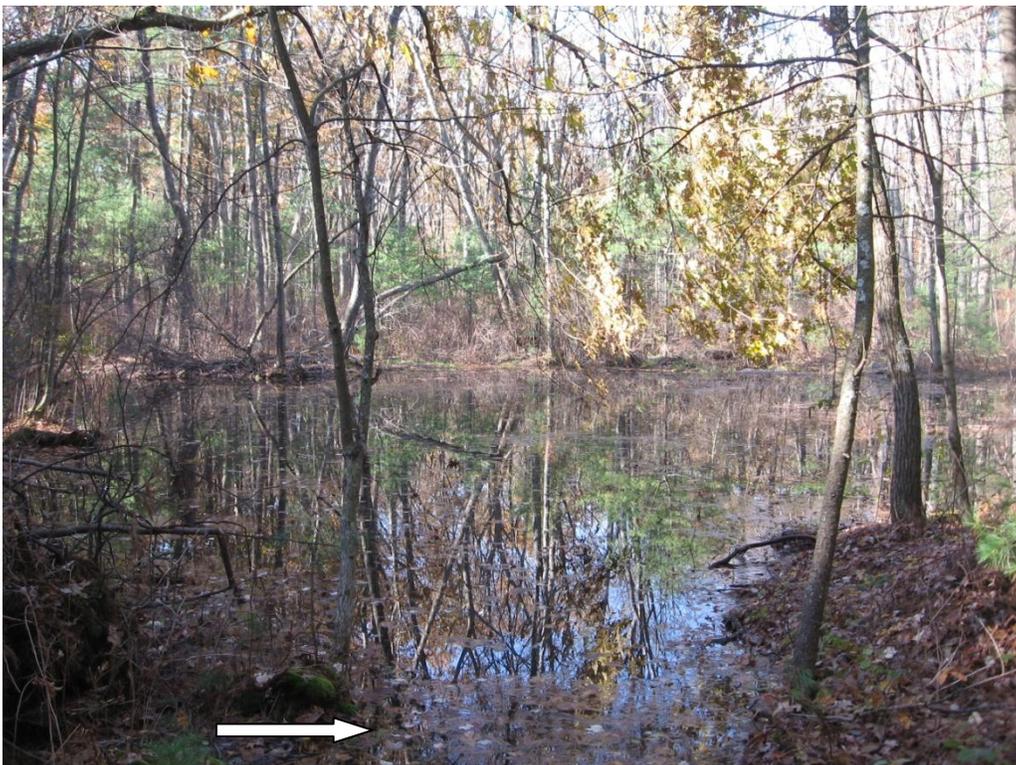
20. Woodland pool, which likely functions as a vernal pool, in woods of Third Street. Note narrow opening in foreground of photo where ATVs have entered and exited the wetland.

The Land Utilization Committee should conduct a survey of the two pools of water that likely function as vernal pools. This requires observing the pool in early spring for the presence of obligate vernal pool species - notably Wood Frogs (*Rana sylvatica*) and Mole salamanders (*Ambystoma spp.*). Instructions for conducting a vernal pool survey and for certifying a pool through the Mass Natural Heritage and Endangered Species Program are included in the appendix of this report. Additionally, to further protect these pools we recommend that trails near their edges be relocated at least 50-feet from their mean annual high water marks. This will help to protect the aquatic and wetland resources which are especially important for these pools to function as breeding habitat for amphibians.
