Eisenhaures Pond Park Natural Resource Inventory and Conceptual Trail Plan

Prepared for the Town of North Reading Land Utilization Committee

**by Elizabeth B. Newlands
Mass Audubon Ecological Extension Service**

January 2012

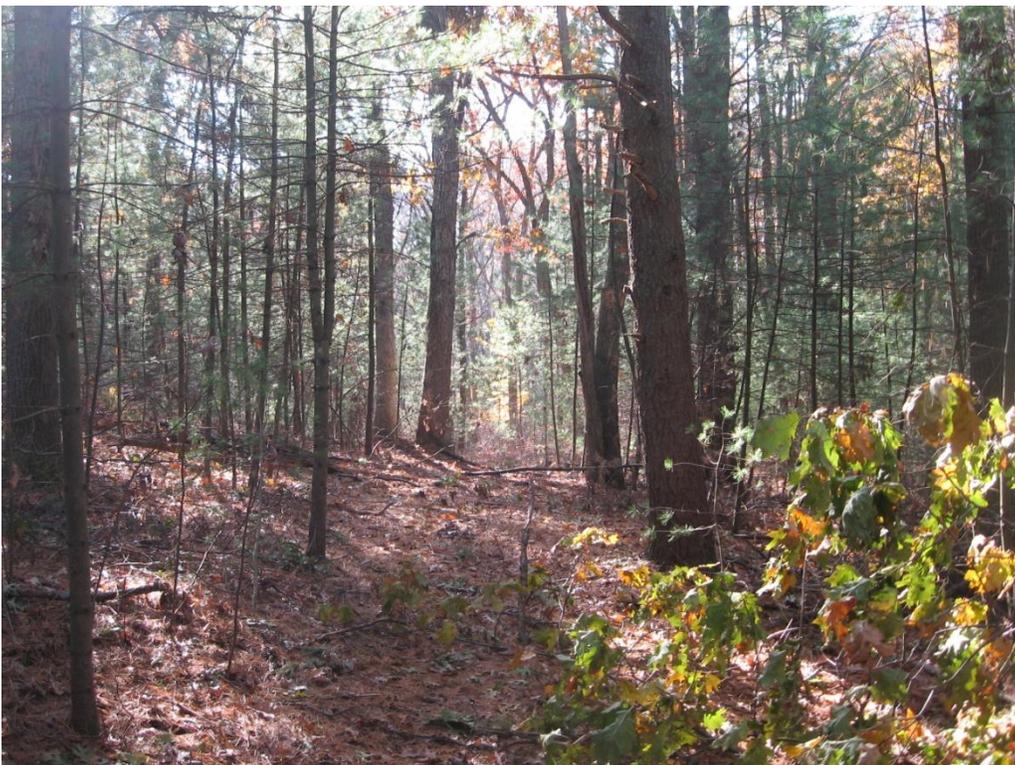
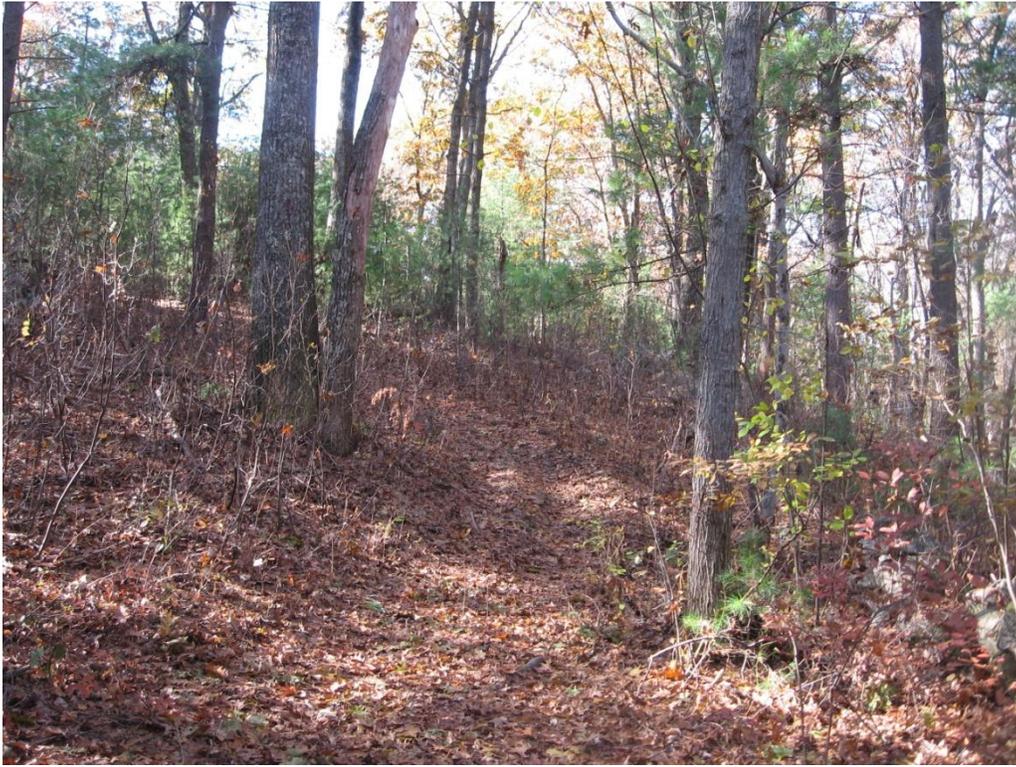
24. Improvised trail created by ATV driving through woods off Third Street.

25. Improvised trail created by ATV driving through woods off Third Street.

Evidence of recent ATV use was observed throughout the western portion of the park. Illegally dumped materials were found at several locations along dirt roads in the interior of the property. Stone fire rings and make-shift wooden “forts” were also found in several locations on the property. These uses reduce the natural resource values of the property and seem to be inconsistent with the intention of providing users with a nature experience. We recommend that the Land Utilization Committee disassemble the forts, disperse the stone fire rings, and investigate the source of the ATV traffic and educate townspeople about the acceptable uses of the property.

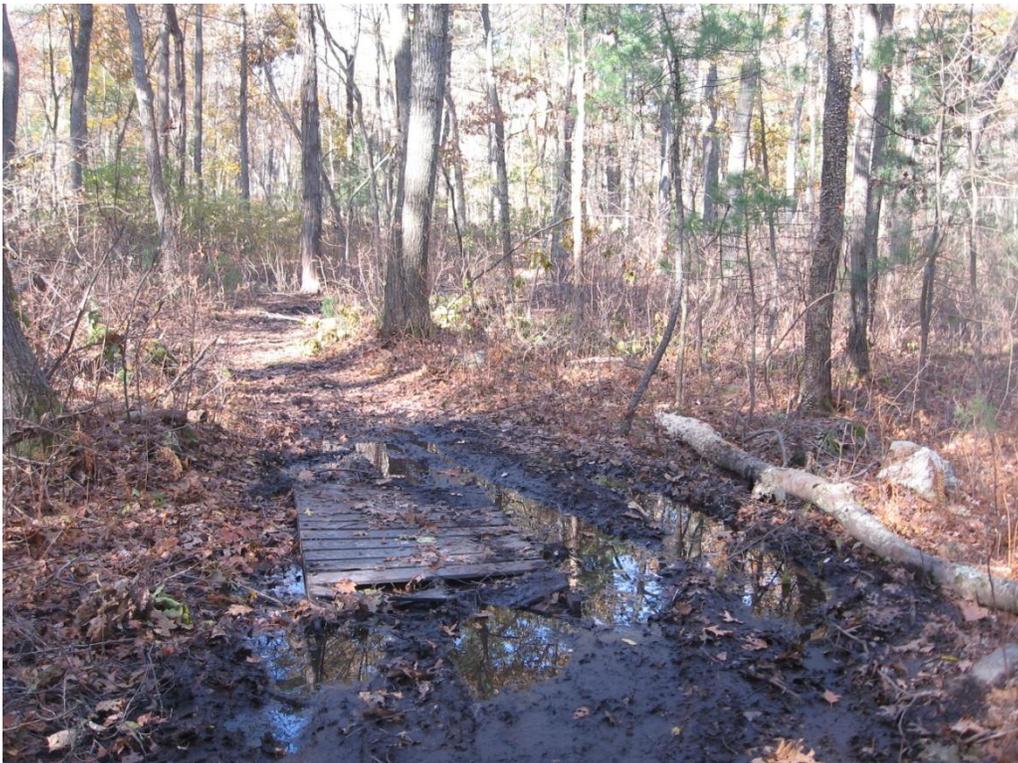
26. ATV trail through Rocky swale in woods off Third Street.
Note planks placed in stream bed. This type of use is damaging to wetlands.

Several existing trails cross wetlands and intermittent streams. These crossings are either on improvised structures (such as pallets laid in the substrate), across stones, or directly through the wetlands at-grade (see photos #16, 26, 29, 47, 48). These crossings are hazardous to visitors or damaging to wetland and aquatic resources. We describe several possible solutions to improving wetland crossings, and depict their locations in the map on Figure 5.

Other crossings will require the construction of a boardwalk or bridge, such as the crossing off First Street (photo #26), or the rocky swale in the southeast corner of the pond (photos #47, 48). However, it may also be possible to reconfigure the stones in the rocky swale so that they are easier to cross. This would allow visitors to navigate the crossing more easily while maintaining the historic nature of the crossing, which appears to be associated with the old well and foundations found nearby.

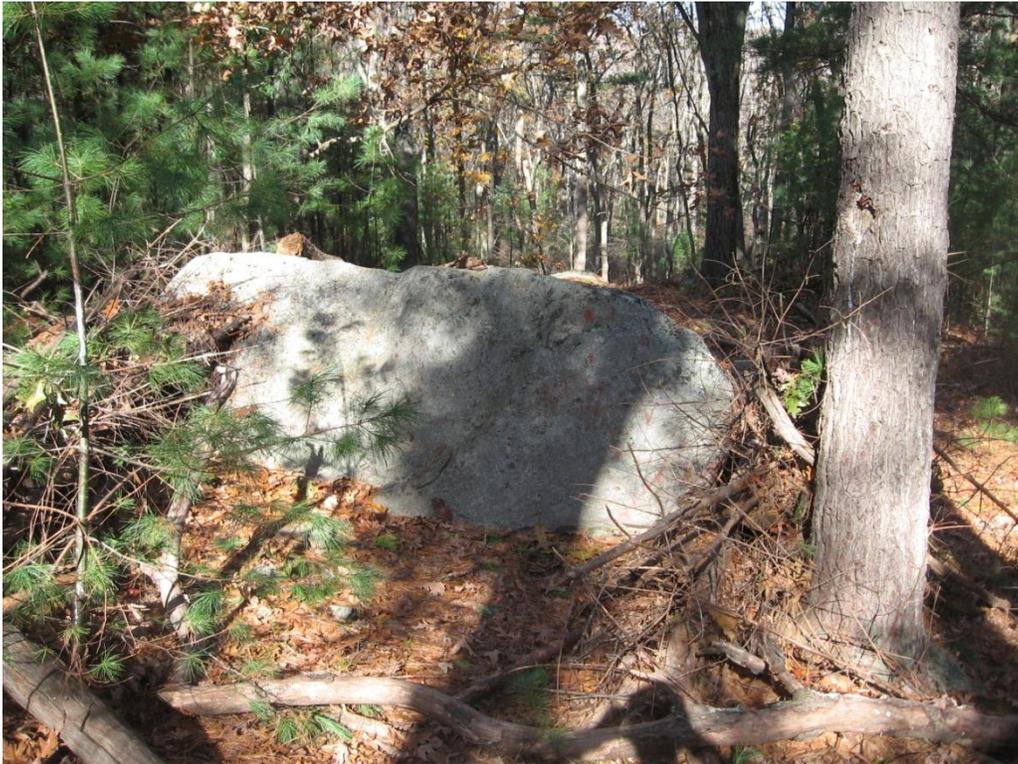
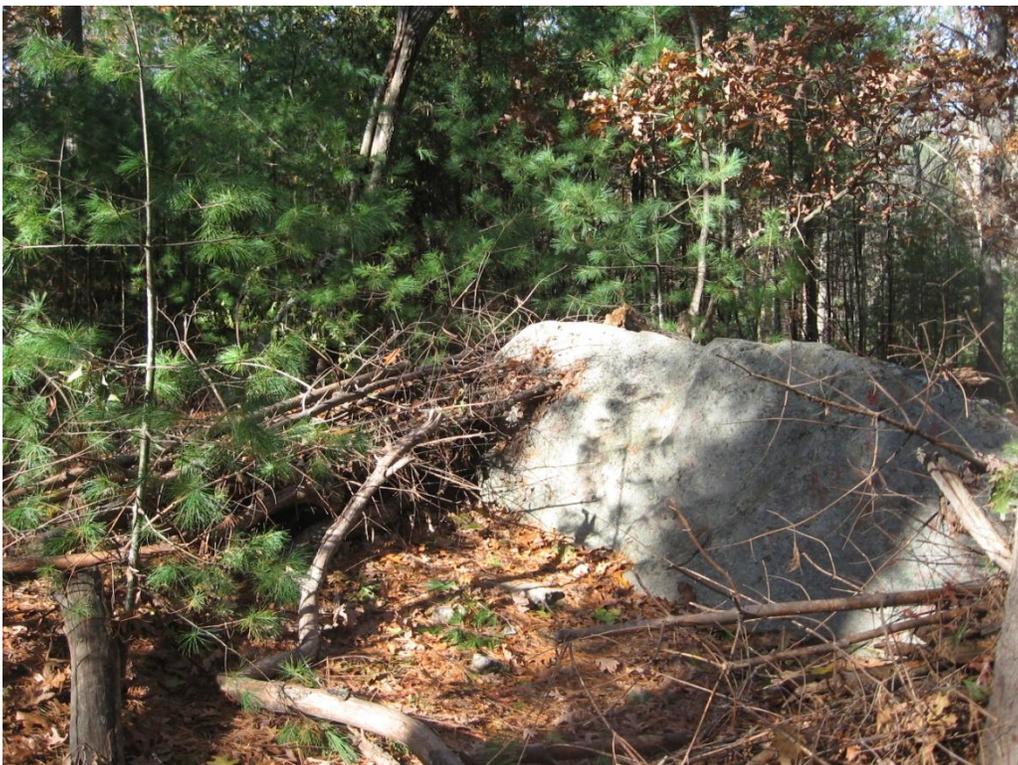
27. Remnants of lean-to in woods off Third Street. The site was likely used for games of paintball combat.

28. Remnants of lean-to in woods off Third Street. The site was likely used for games of paintball combat.

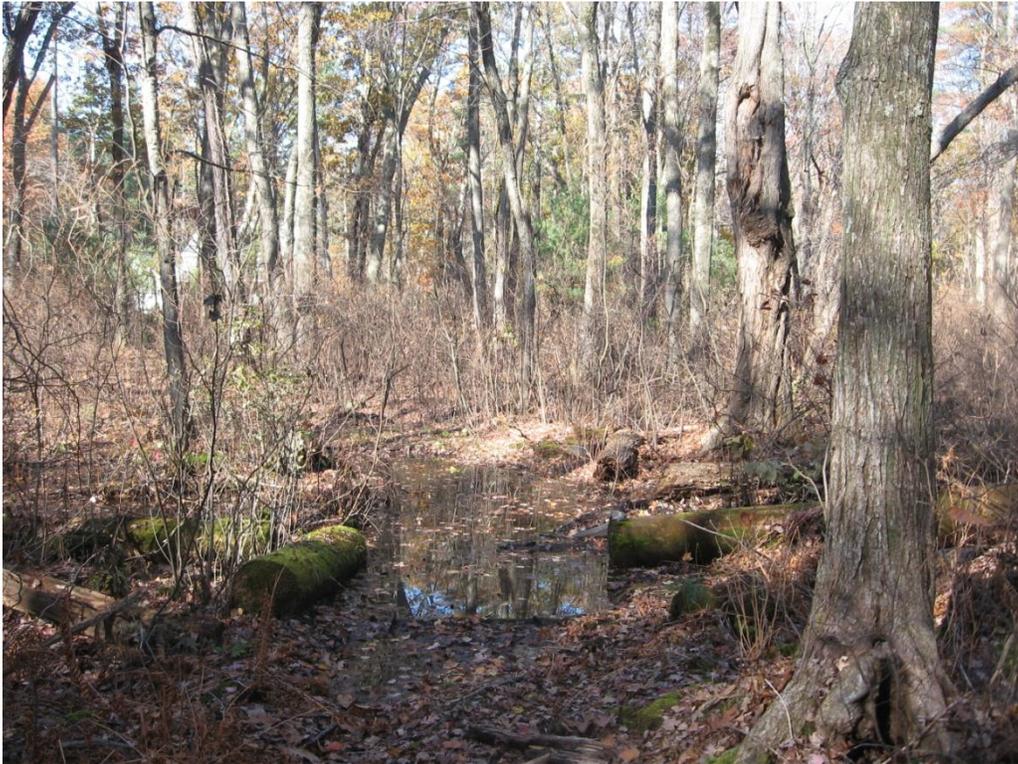
29. ATV trail through wetlands in western portion of the property.

When trails that cross at-grade through wetlands cannot be located outside of the bordering vegetated wetland, we recommend that they be replaced with a “bogwalk” - boards laid across and affixed to logs set in the ground.

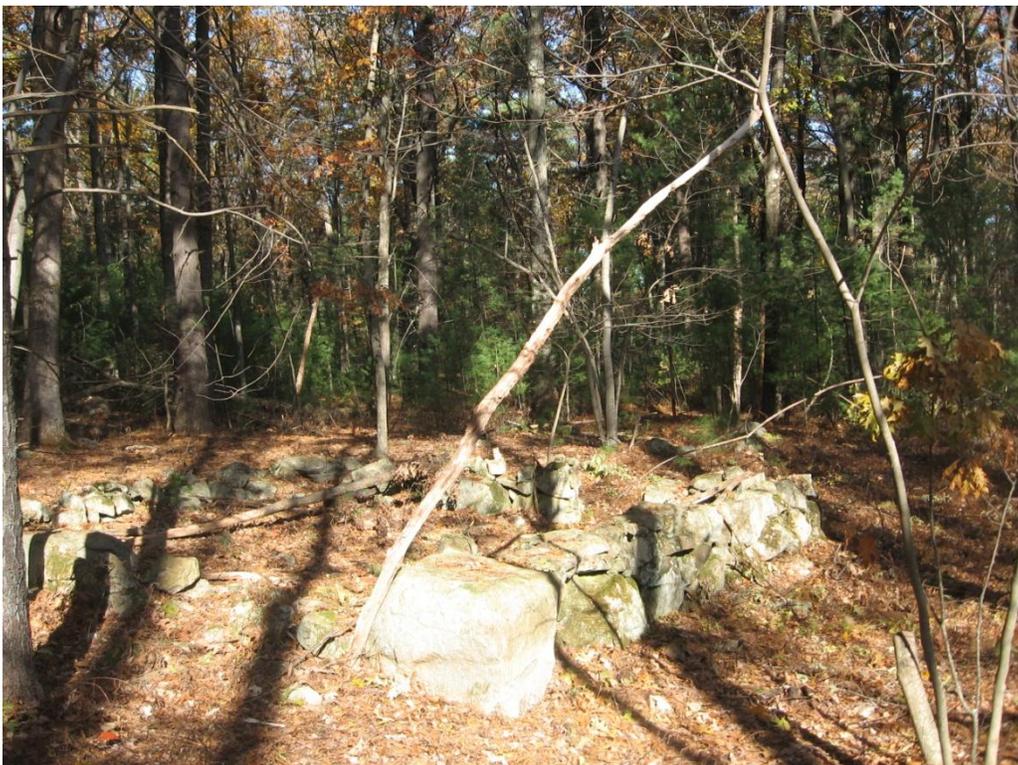
32. Old foundation in woods off Third Street.

Cultural features such as these are interesting to visitors and present an opportunity for interpretation.

In addition to the natural resources on the property, there are also remnants of our cultural past. Several old foundations, wells and numerous stone walls are located on the property (photo #s 14, 15, 17, 23, 32, 33, 35, 43, 44, 45, 47 & 48). These tell of past habitation and farming on the property. These cultural features merit protection just as natural resources do, and therefore should not be altered.

Discovering cultural features is akin to discovering treasures and is often a powerful experience for visitors. We suggest the Land Utilization Committee consult with local historians and develop a plan to interpret the local land-use history, and to provide the public with an educational experience through signage or an interpretive trail. However, the abandoned wells do present somewhat of a hazard. At a minimum we suggest using downed wood to cordon the wells off to call people's attention to them. We strongly advise that the Land Utilization Committee consult with the Historic Commission to investigate the archaeological significance of the wells, and fill them with sand/gravel if warranted.

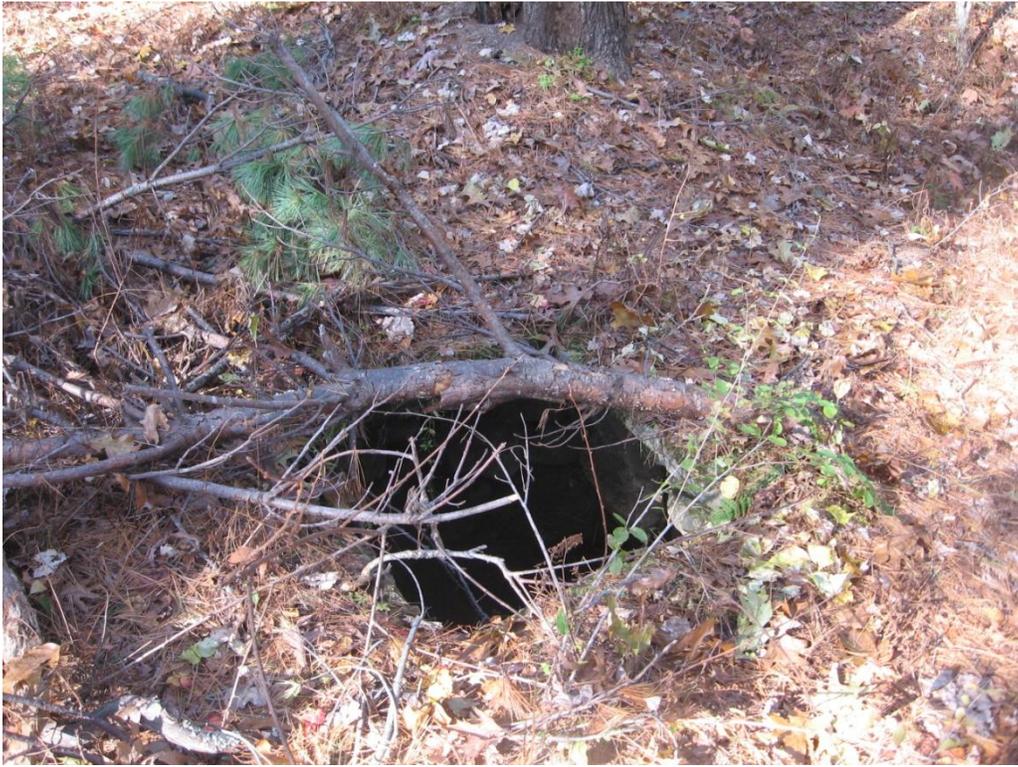
33. Old well in woods off Third Street. We recommend erecting some type of structure to that provides interpretive history and alerts visitors to this potential hazard.

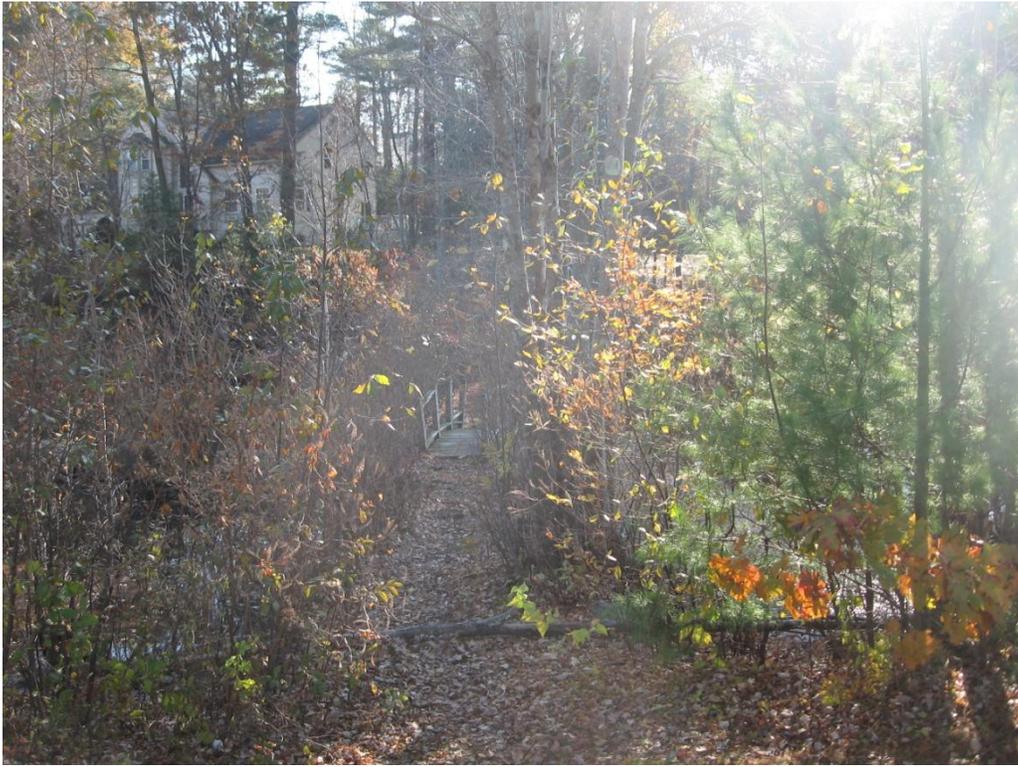
37. Path and footbridge across beaver dam at eastern end of Eisenhaures Pond, at the intersection of Eisenhaures Lane and Oscar's Way.

Though this is currently one of the most commonly used access points, we recommend closing the trail over the beaver dam and keeping the small park for its attractive view onto the pond. The trail is located in a bordering vegetated wetland. This is an important natural resource which attenuates flood waters, protects water supply, improves water quality, and provides wildlife habitat. The current trail layout requires the adventurous to cross the beaver dam (and a recently installed pre-fabricated foot bridge) and is not suitable for a dedicated trail: on the far side of the beaver dam, the trail runs right behind the backyards of houses on Burnham Drive, detracting from the quality of the visitor experience.

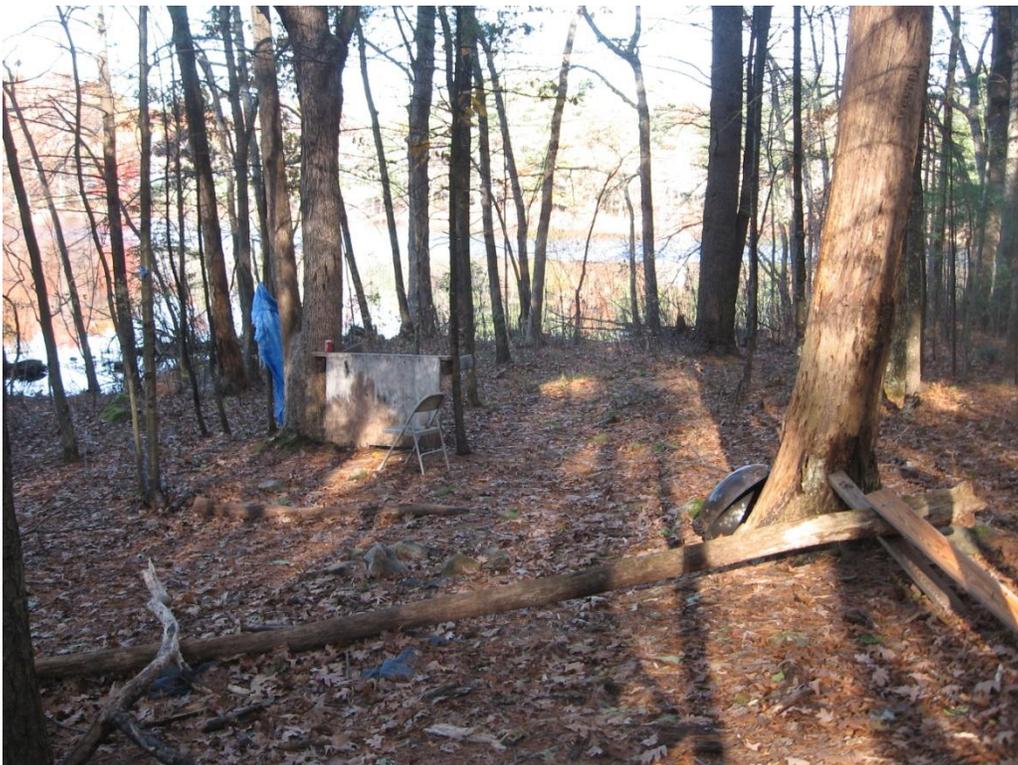
42. Trash, debris, and remnants of forts on south side of pond. The forts are likely used for paintball combat.

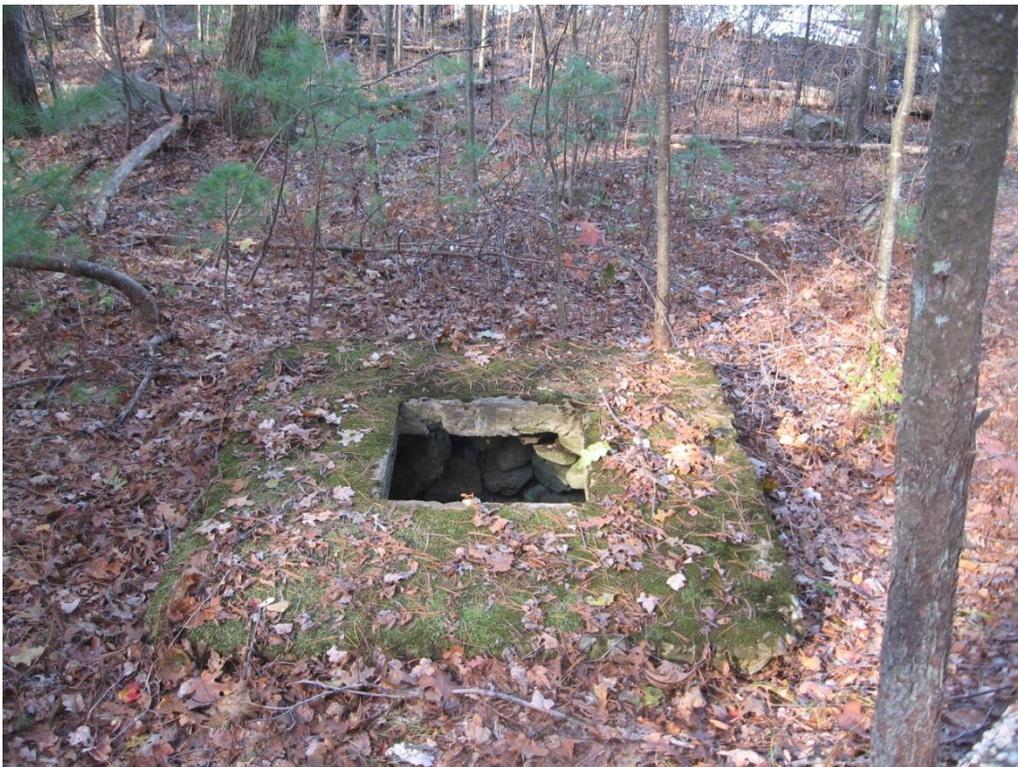
44. Old well in woods off Third Street. We recommend erecting some type of structure to provide interpretive history and alerts visitors to this potential hazard.

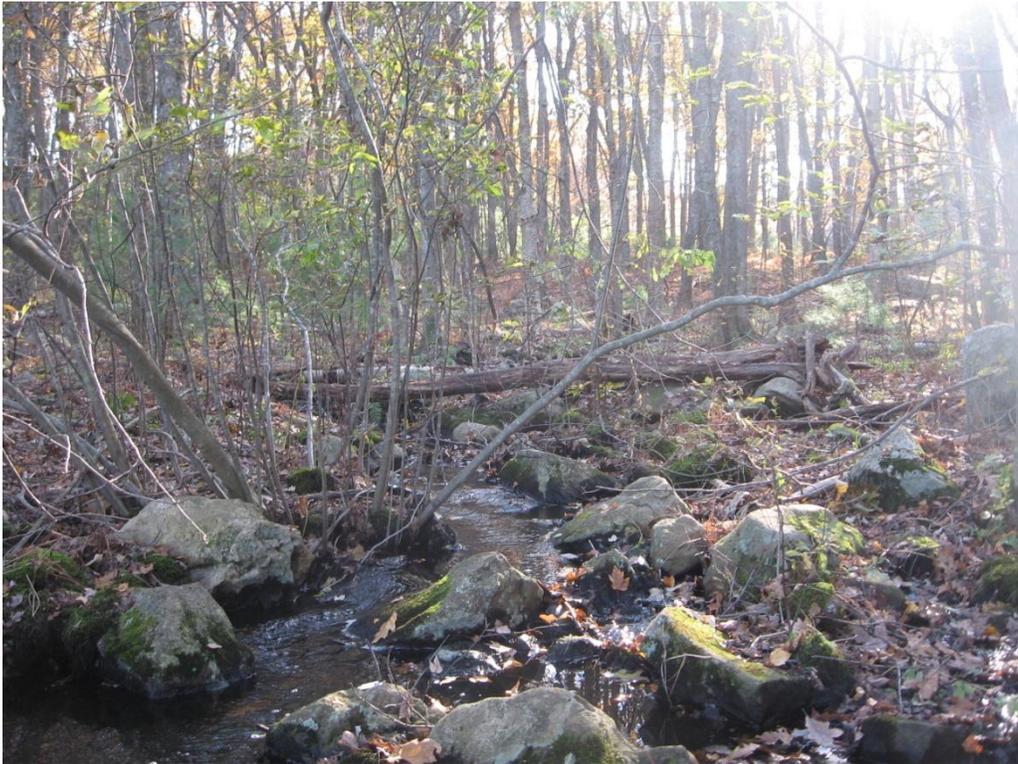
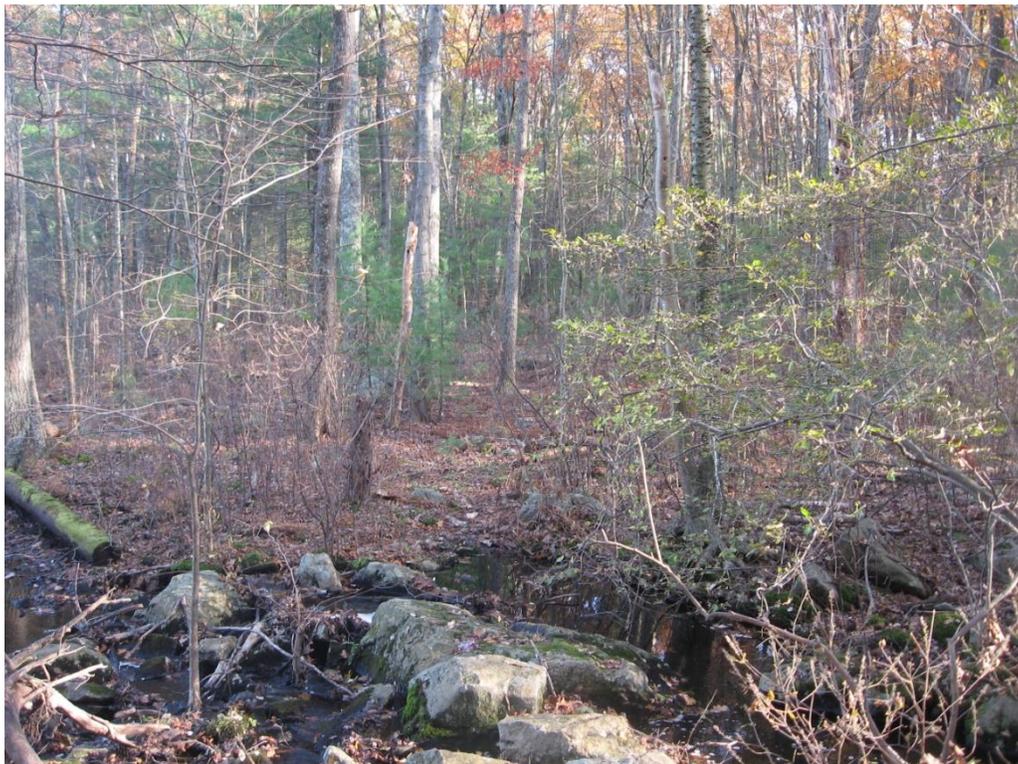
47. Rocky swale at the southwest corner of Eishenhaures Pond Park.
An existing footpath along the margin of the pond follows stones across the stream.

48. Stepping stones across the rocky swale at southwest corner of Eisenhaures Pond.
The stones are difficult to negotiate and the crossing would benefit from improvements.
