Town of North Reading Massachusetts  
Department of Public Works  
Water Department

Water System Leak Detection Survey Report  
2014

Arthur Pyburn & Sons Inc.

The following is a summary of leak detection performed on 80 miles of the North Reading Water Department's distribution system.

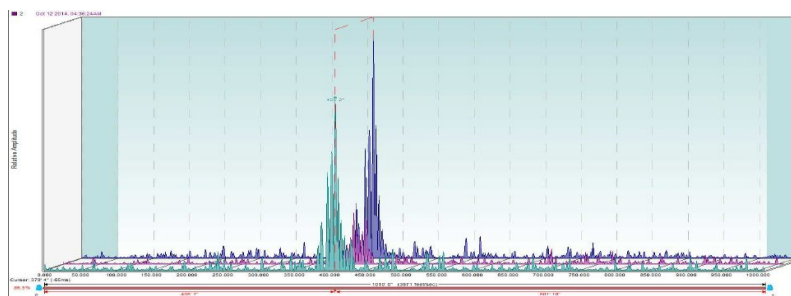
Location: An abandoned service on Haverhill Street by the Ipswich River across from pole 153

Approx. Size: 1-2 GPM

Pipe ID	Length	Diameter	Material	Sound Velocity
P8	1010' 0"	10"	Cast Iron	3871 feet/sec

Leak ID	Leak Position	Correlation Between	Confidence	Recording Time
L31	408' 2" from 2	2 → 1	88.5%	Oct 12 2014, 04:35:24AM
L32	407' 9" from 2	2 → 1	88.5%	Oct 12 2014, 04:35:24AM
L33	408' 2" from 2	2 → 1	88.2%	Oct 12 2014, 04:37:24AM
L34	722' 9" from 1	1 → 3	88.8%	Oct 12 2014, 04:35:24AM
L35	722' 4" from 1	1 → 3	89.9%	Oct 12 2014, 04:35:24AM
L36	722' 9" from 1	1 → 3	90.4%	Oct 12 2014, 04:37:24AM
L40	408' 2" from 2	2 → 1	88.5%	Oct 12 2014, 04:35:24AM
L47	407' 9" from 2	2 → 1	88.5%	Oct 12 2014, 04:35:24AM
L48	408' 2" from 2	2 → 1	88.2%	Oct 12 2014, 04:37:24AM

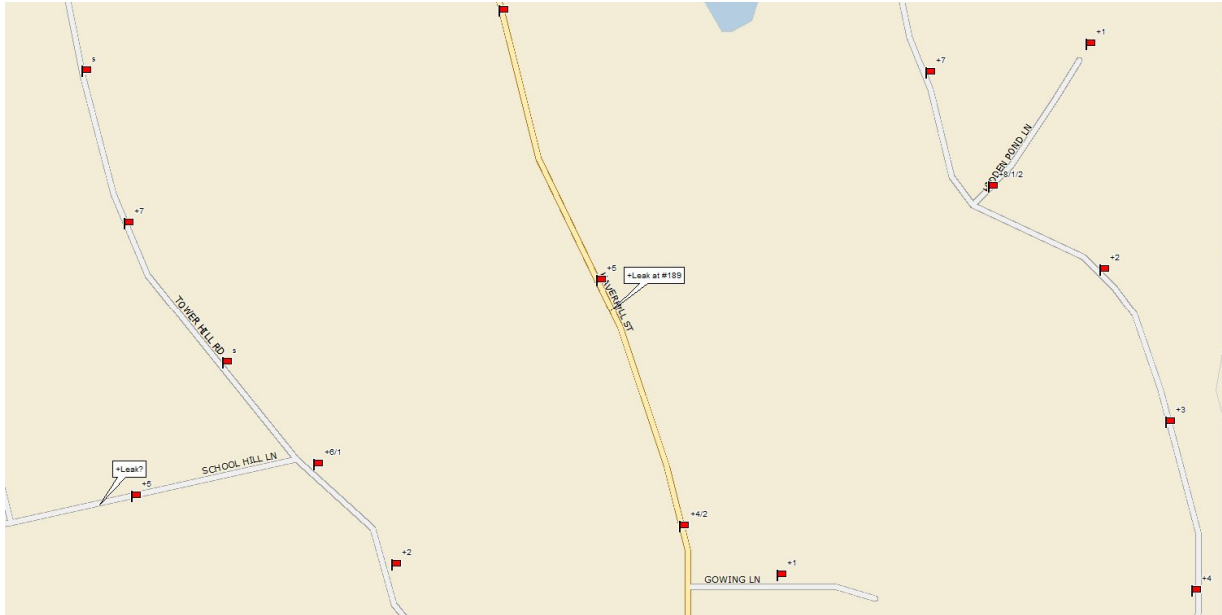
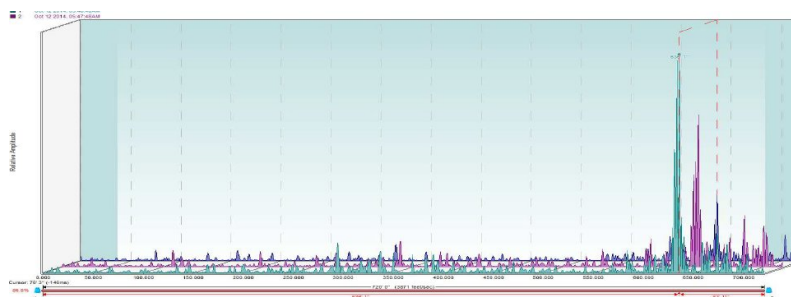
Location: 189 Haverhill Street, Service Leaking

Approx. Size: 2-4 GPM

Pipe ID	Length	Diameter	Material	Sound Velocity
P4	725' 0"	10"	Cast Iron	3871 feet/sec

Leak ID	Leak Position	Correlation Between	Confidence	Recording Time
L16	530' 1" from 4	4 -> 5	86.8%	Oct 12 2014, 05:46:48AM
L17	530' 5" from 4	4 -> 5	86.3%	Oct 12 2014, 05:47:48AM
L18	530' 1" from 4	4 -> 5	81.1%	Oct 12 2014, 05:48:48AM
L34	530' 5" from 4	4 -> 5	84.7%	Oct 12 2014, 05:47:48AM
L35	530' 1" from 4	4 -> 5	81.1%	Oct 12 2014, 05:48:48AM

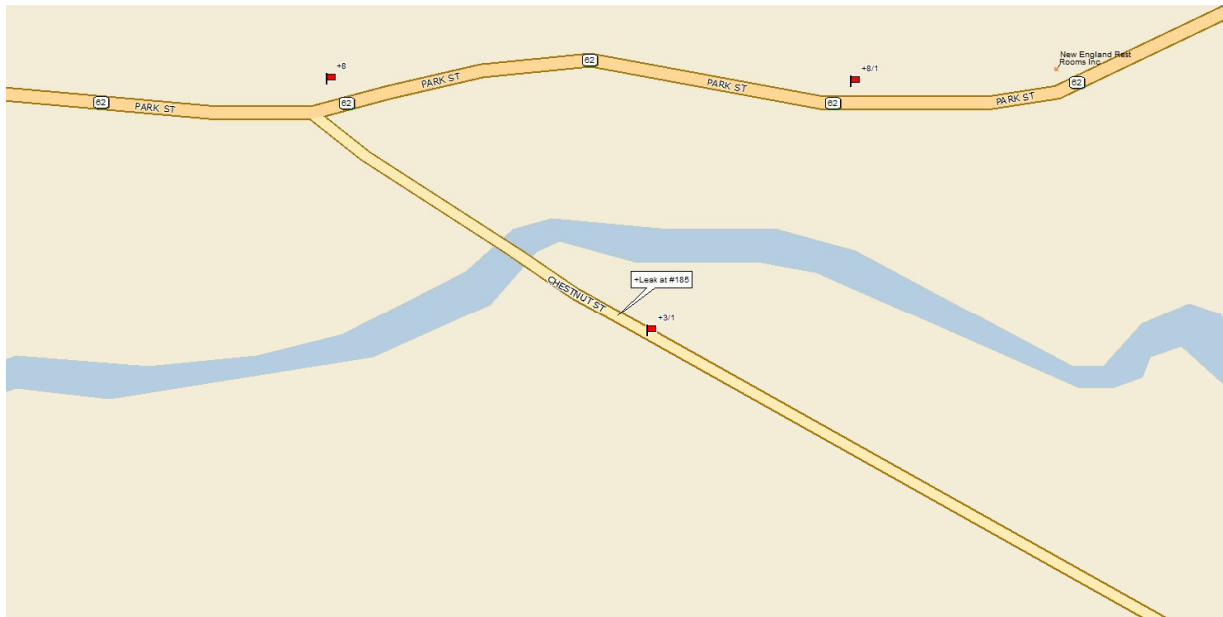
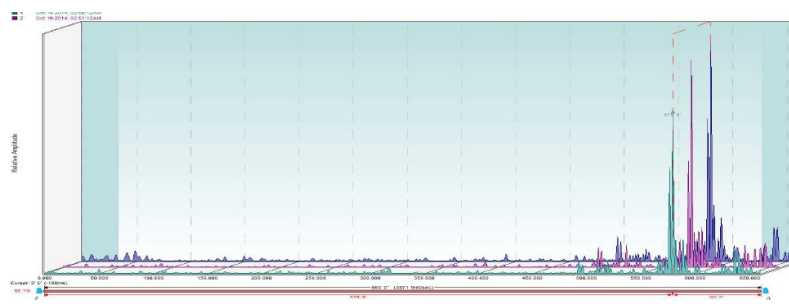
Location: 185 Chestnut Street, Service Leaking

Approx. Size: 1-3 GPM

Pipe ID	Length	Diameter	Material	Sound Velocity
PT	880' 0"	10"	Cast Iron	3871 feet/sec

Leak ID	Leak Position	Correlation Between	Confidence	Recording Time
L22	1265' 7" from 4	4 -> 3	80.8%	Oct 19 2014, 02:50:12AM
L23	1265' 2" from 4	4 -> 3	79.2%	Oct 19 2014, 02:51:12AM
L29	1405' 11" from 1	1 -> 3	80.6%	Oct 19 2014, 02:51:12AM
L30	1405' 11" from 1	1 -> 3	74.2%	Oct 19 2014, 02:52:12AM
L31	870' 0" from 2	2 -> 3	80.1%	Oct 19 2014, 02:50:12AM
L32	870' 0" from 2	2 -> 3	80.1%	Oct 19 2014, 02:51:12AM
L33	860' 1" from 2	2 -> 3	89.8%	Oct 19 2014, 02:52:12AM

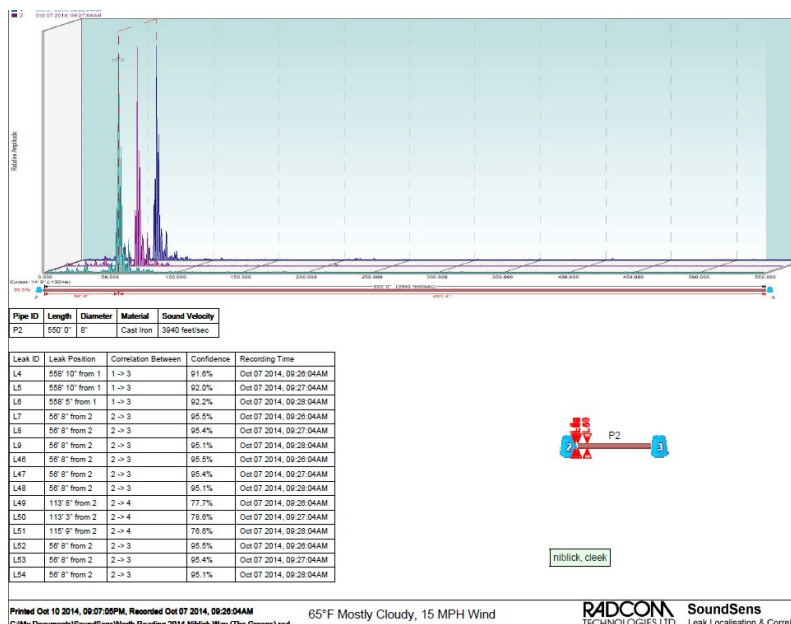
Location: 51 Niblick Way, Service leaking

Approx. Size: 1-3 GPM

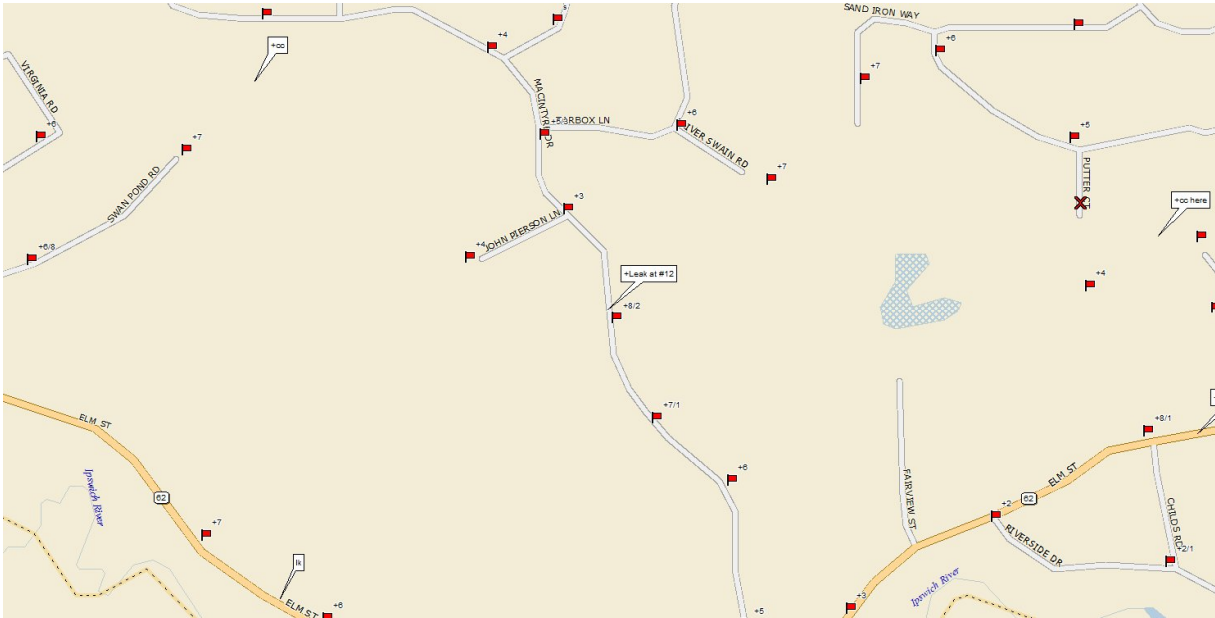
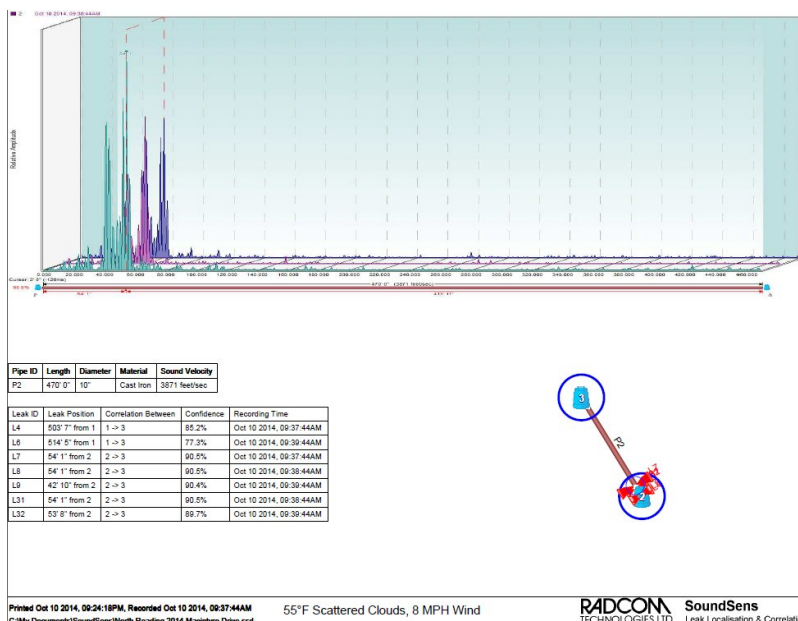
Location: 12 Macintyre Drive, Service Leaking

Approx. Size: 1-3 GPM

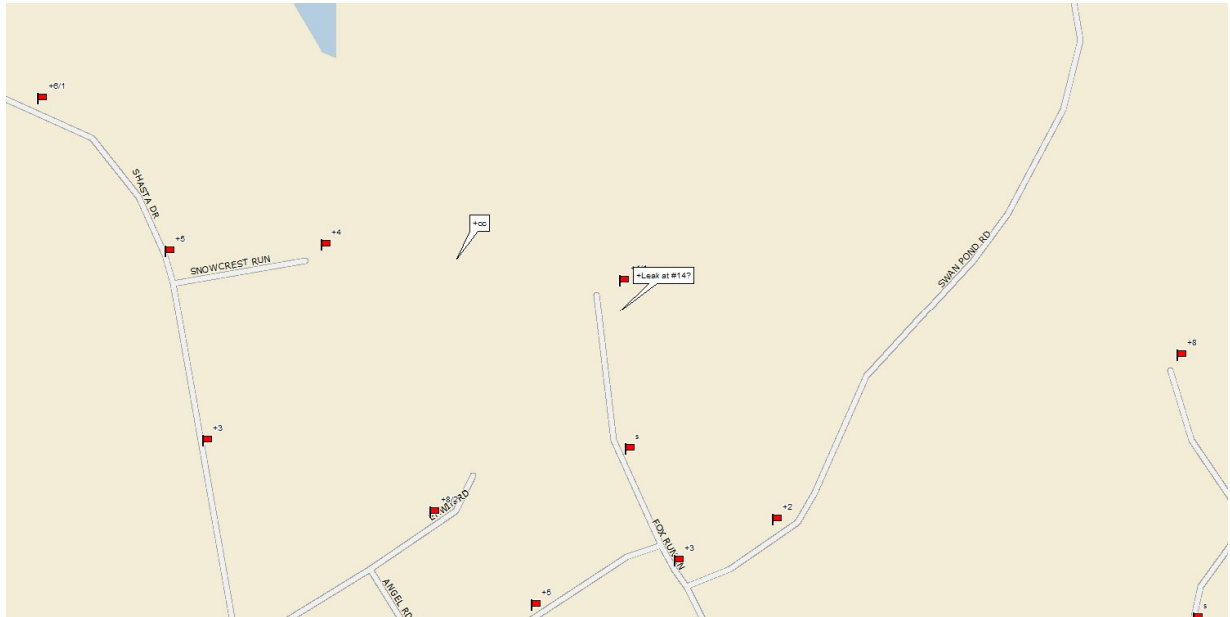
**Location:** 14 Fox Run Lane, Service Leaking

**Approx. Size:** 2-4 GPM

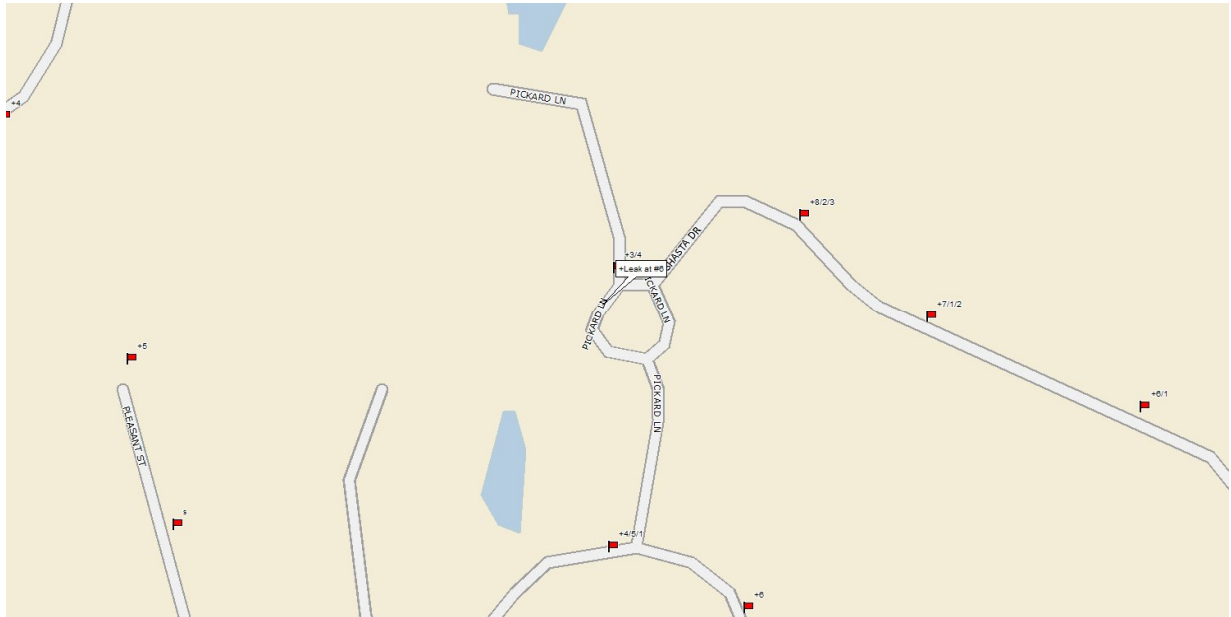
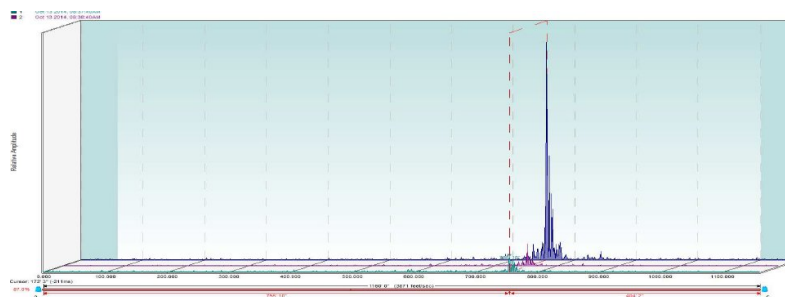
Location: 6 Pickard Lane, Service Leaking

Approx. Size: 1-3 GPM

Pipe ID	Length	Diameter	Material	Sound Velocity
P3	500' 0"	10"	Cast Iron	3871 feet/sec
P4	650' 0"	10"	Cast Iron	3871 feet/sec

Leak ID	Leak Position	Correlation Between	Confidence	Recording Time
L10	270' 0" from 3	3 -> 4	70.4%	Oct 13 2014, 08:37:40AM
L11	220' 5" from 3	3 -> 4	82.8%	Oct 13 2014, 08:38:40AM
L12	200' 7" from 3	3 -> 4	72.3%	Oct 13 2014, 08:39:40AM
L13	750' 10" from 3	3 -> 5	87.0%	Oct 13 2014, 08:37:40AM
L14	753' 10" from 3	3 -> 5	89.0%	Oct 13 2014, 08:38:40AM
L15	753' 10" from 3	3 -> 5	85.0%	Oct 13 2014, 08:39:40AM
L16	520' 0" from 4	4 -> 5	87.2%	Oct 13 2014, 08:37:40AM
L17	520' 0" from 4	4 -> 5	75.0%	Oct 13 2014, 08:38:40AM
L18	524' 10" from 4	4 -> 5	77.9%	Oct 13 2014, 08:39:40AM
L34	753' 10" from 3	3 -> 5	89.0%	Oct 13 2014, 08:38:40AM
L35	753' 10" from 3	3 -> 5	95.0%	Oct 13 2014, 08:39:40AM

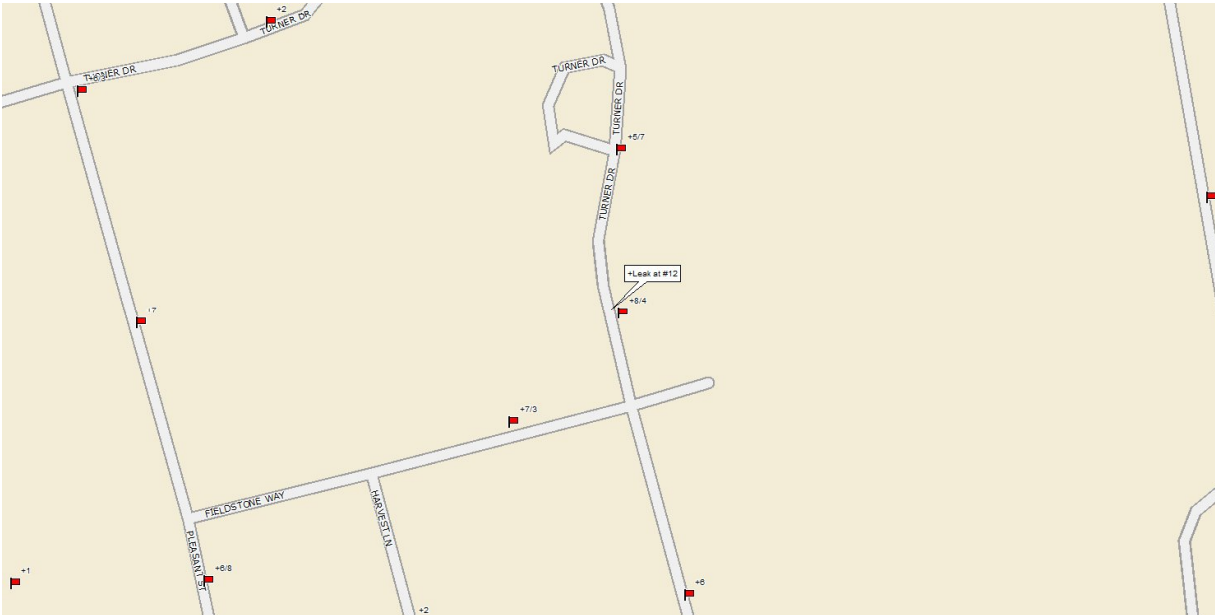
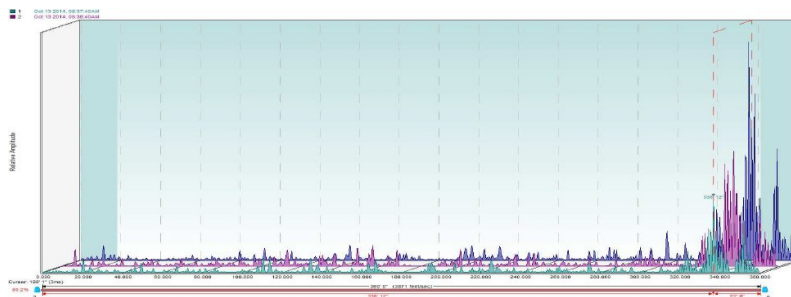
Location: 12 Turner Drive, Service Leaking

Approx. Size: 1-3 GPM

Pipe ID	Length	Diameter	Material	Sound Velocity
P7	300' 0"	10"	Cast Iron	3871 feet/sec

Leak ID	Leak Position	Correlation Between	Confidence	Recording Time
L28	336' 12" from 7	7 → 8	80.2%	Oct 13 2014, 08:37:40AM
L29	337' 10" from 7	7 → 8	80.1%	Oct 13 2014, 08:38:40AM
L30	336' 5" from 7	7 → 8	85.2%	Oct 13 2014, 08:39:40AM
L32	88' 9" from 8	8 → 6	71.1%	Oct 13 2014, 08:39:40AM
L33	87' 11" from 8	8 → 6	80.4%	Oct 13 2014, 08:39:40AM
L34	337' 10" from 7	7 → 8	80.1%	Oct 13 2014, 08:39:40AM
L35	336' 5" from 7	7 → 8	84.6%	Oct 13 2014, 08:39:40AM

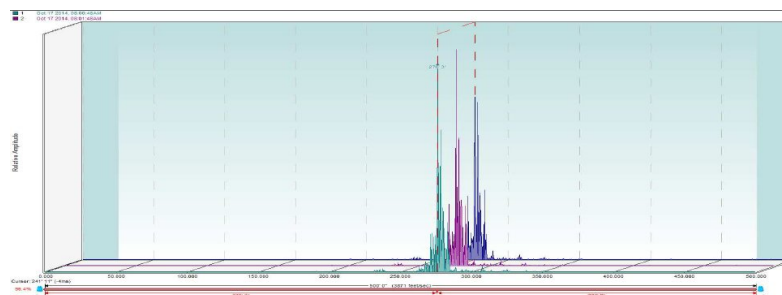
Location: 9 Heritage Way, Service Leaking

Approx. Size: 1-3 GPM

Pipe ID	Length	Diameter	Material	Sound Velocity
P3	500' 0"	10"	Cast Iron	3871 feet/sec

Leak ID	Leak Position	Correlation Between	Confidence	Recording Time
L10	278' 3" from 2	2 -> 3	99.4%	Oct 17 2014, 08:00:48AM
L11	278' 3" from 2	2 -> 3	99.3%	Oct 17 2014, 08:01:48AM
L12	278' 11" from 2	2 -> 3	99.0%	Oct 17 2014, 08:02:48AM
L15	358' 9" from 2	2 -> 4	94.4%	Oct 17 2014, 08:02:48AM
L31	278' 3" from 2	2 -> 3	99.3%	Oct 17 2014, 08:01:48AM
L32	278' 3" from 2	2 -> 3	99.8%	Oct 17 2014, 08:02:48AM

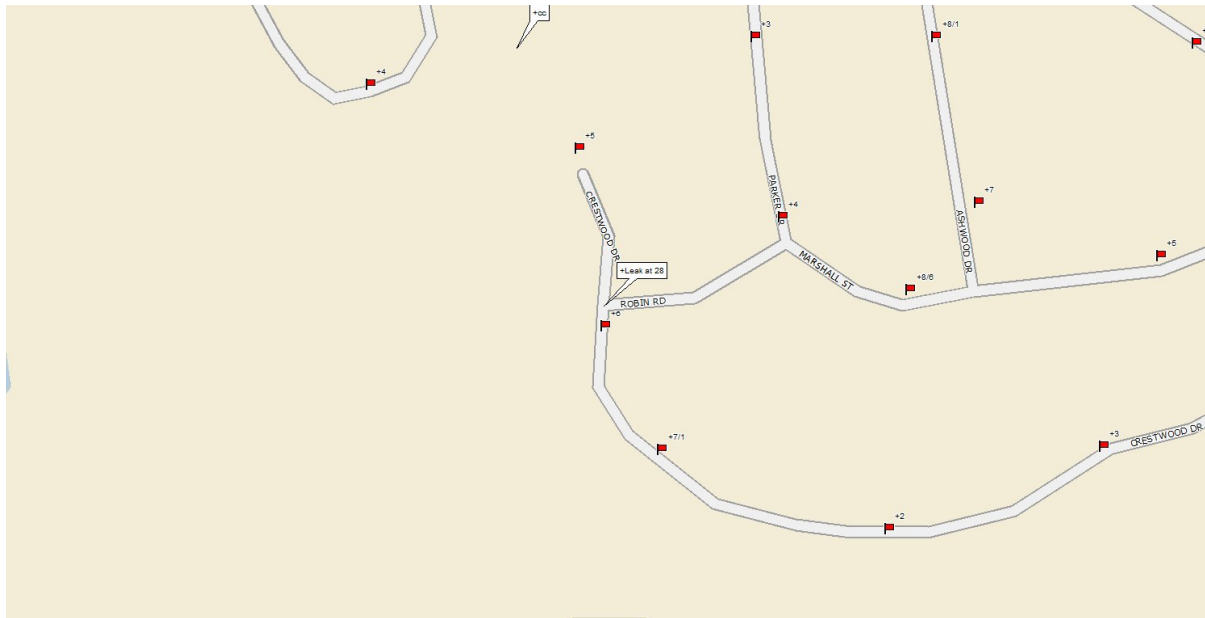
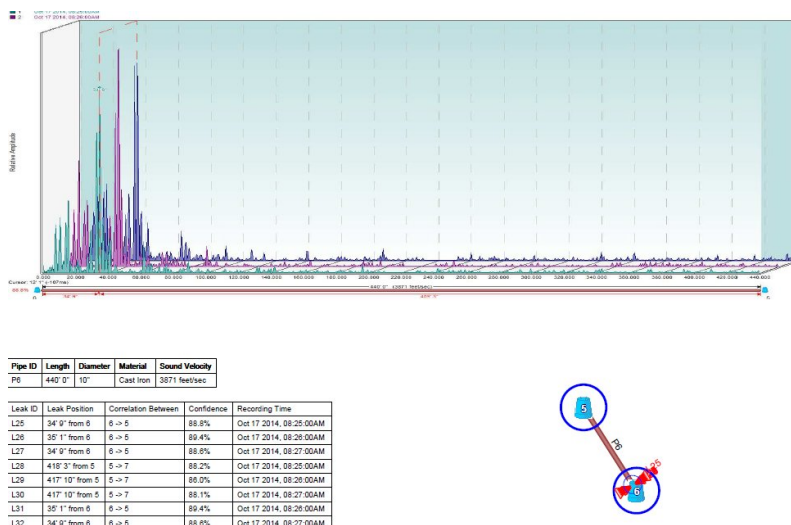
Location: 28 Crestwood, Service Leaking, Main to Box to Cellar

Approx. Size: 2-4 GPM

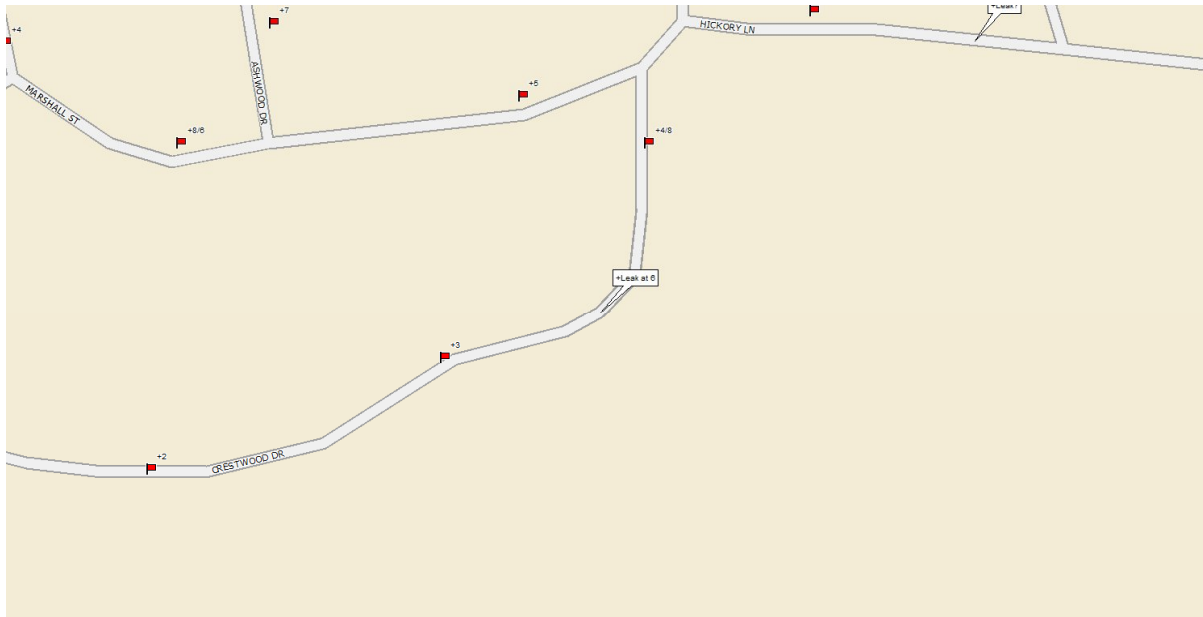
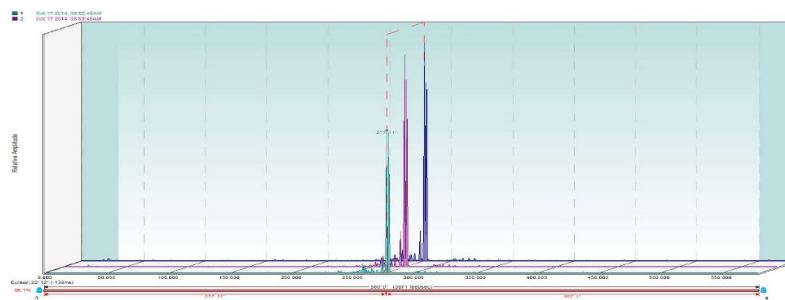
Location: 6 Crestwood Drive, Service Leaking

Approx. Size: 1-3 GPM

Pipe ID	Length	Diameter	Material	Sound Velocity
P3	580' 0"	10"	Cast Iron	3571 feet/sec

Leak ID	Leak Position	Correlation Between	Confidence	Recording Time
L10	277' 11" from 3	3 -> 4	98.1%	Oct 17 2014, 08:52:48AM
L11	277' 8" from 3	3 -> 4	98.4%	Oct 17 2014, 08:53:48AM
L12	278' 4" from 3	3 -> 4	98.4%	Oct 17 2014, 08:54:48AM
L13	325' 5" from 3	3 -> 5	92.2%	Oct 17 2014, 08:52:48AM
L14	325' 5" from 3	3 -> 5	92.5%	Oct 17 2014, 08:53:48AM
L15	325' 5" from 3	3 -> 5	91.0%	Oct 17 2014, 08:54:48AM
L34	277' 8" from 3	3 -> 4	98.4%	Oct 17 2014, 08:53:48AM
L35	278' 4" from 3	3 -> 4	98.4%	Oct 17 2014, 08:54:48AM

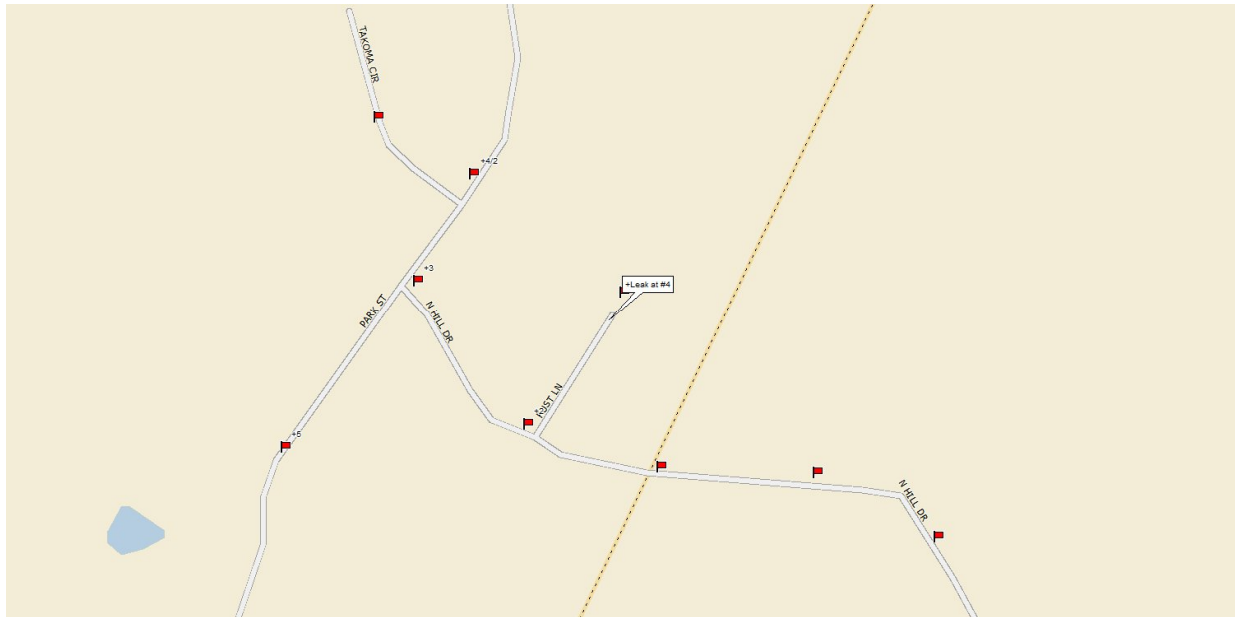
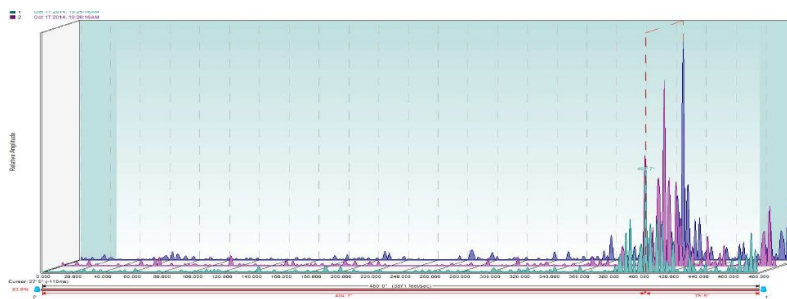
Location: 4 Rust Lane, Service Leaking

Approx. Size: 2-4 GPM

Pipe ID	Length	Diameter	Material	Sound Velocity
P7	480' 0"	10"	Cast Iron	3871 feet/sec

Leak ID	Leak Position	Correlation Between	Confidence	Recording Time
L28	404' 7" from 2	2 -> 1	83.5%	Oct 17 2014, 10:25:16AM
L29	404' 2" from 2	2 -> 1	85.6%	Oct 17 2014, 10:26:16AM
L30	404' 7" from 2	2 -> 1	87.2%	Oct 17 2014, 10:27:16AM
L31	137' 11" from 1	1 -> 3	79.2%	Oct 17 2014, 10:28:16AM
L32	150' 8" from 1	1 -> 3	74.6%	Oct 17 2014, 10:28:16AM
L34	404' 7" from 2	2 -> 1	85.5%	Oct 17 2014, 10:28:16AM
L35	404' 7" from 2	2 -> 1	87.2%	Oct 17 2014, 10:27:16AM

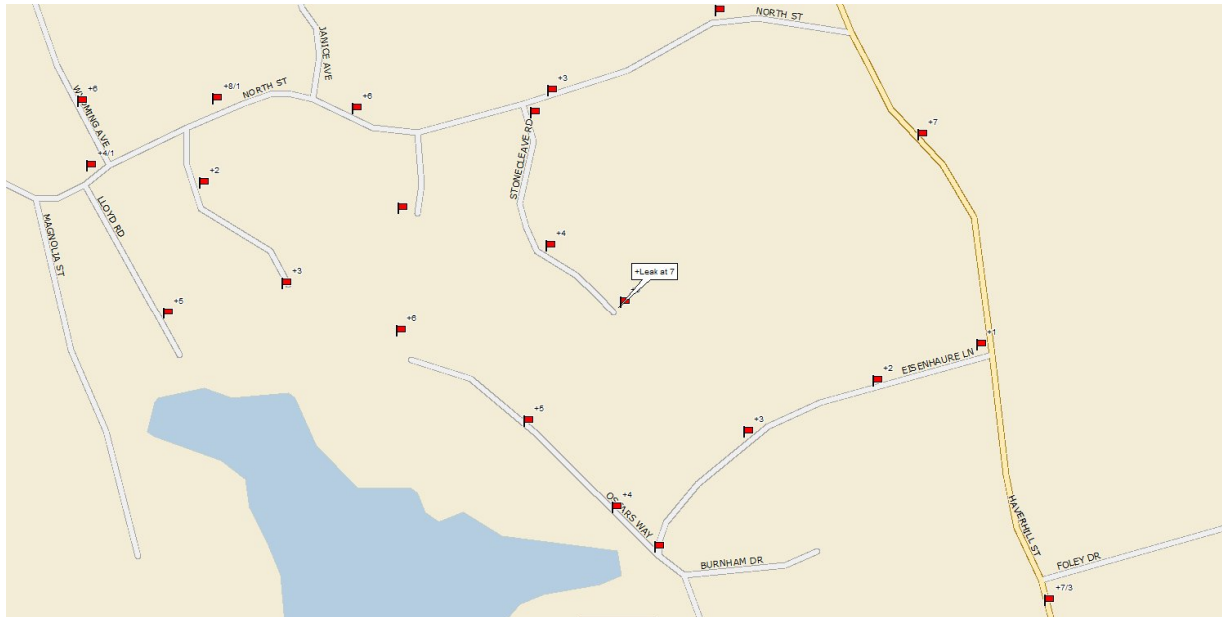
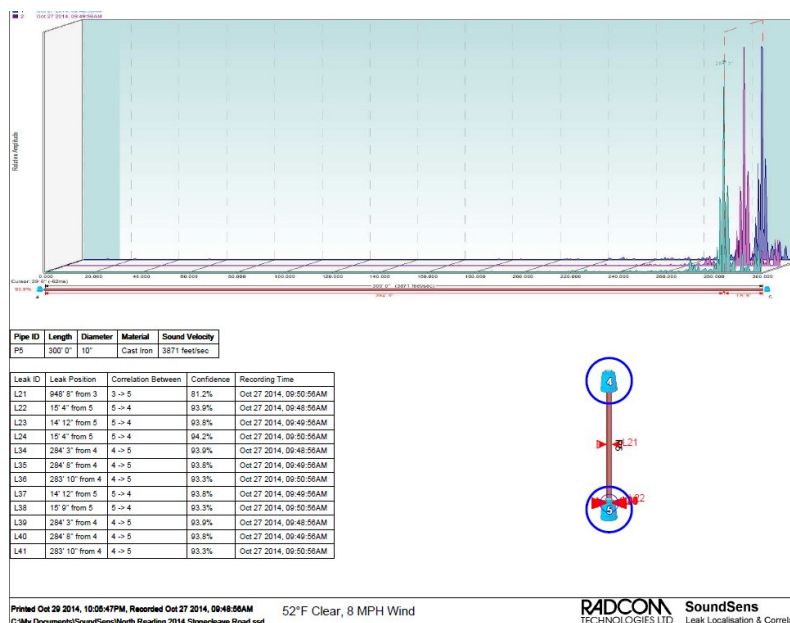
Location: 7 Stonecleave Road, Service Leaking

Approx. Size: 1-3 GPM

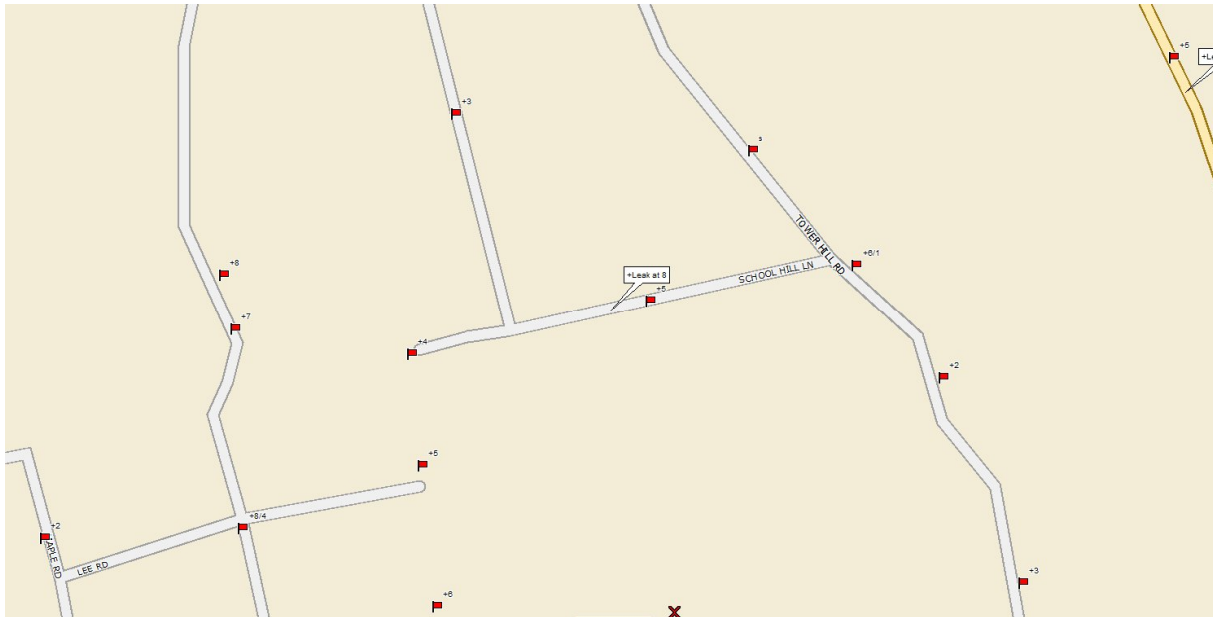
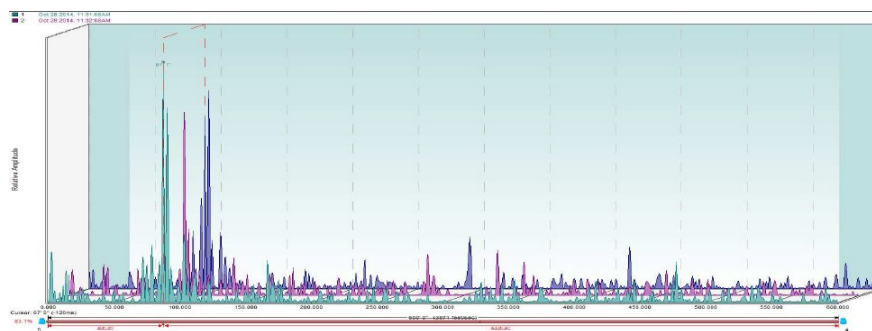
Location: 8 School Hill Lane, Service Leaking

Approx. Size: 2-4 GPM

Pipe ID	Length	Diameter	Material	Sound Velocity
P5	270' 0"	10"	Cast Iron	3871 feet/sec
P6	330' 0"	10"	Cast Iron	3871 feet/sec

Leak ID	Leak Position	Correlation Between	Confidence	Recording Time
L16	787' 8" from 3	3 → 4	72.0%	Oct 28 2014, 11:31:08AM
L18	687' 12" from 3	3 → 4	70.6%	Oct 28 2014, 11:33:08AM
L19	87' 7" from 5	5 → 4	83.1%	Oct 28 2014, 11:31:08AM
L20	88' 0" from 5	5 → 4	81.4%	Oct 28 2014, 11:32:08AM
L21	90' 5" from 5	5 → 4	83.0%	Oct 28 2014, 11:33:08AM
L22	154' 1" from 5	5 → 3	72.1%	Oct 28 2014, 11:31:08AM
L23	200' 4" from 5	5 → 3	69.8%	Oct 28 2014, 11:32:08AM
L40	88' 0" from 5	5 → 4	81.4%	Oct 28 2014, 11:32:08AM
L41	90' 5" from 5	5 → 4	83.0%	Oct 28 2014, 11:33:08AM

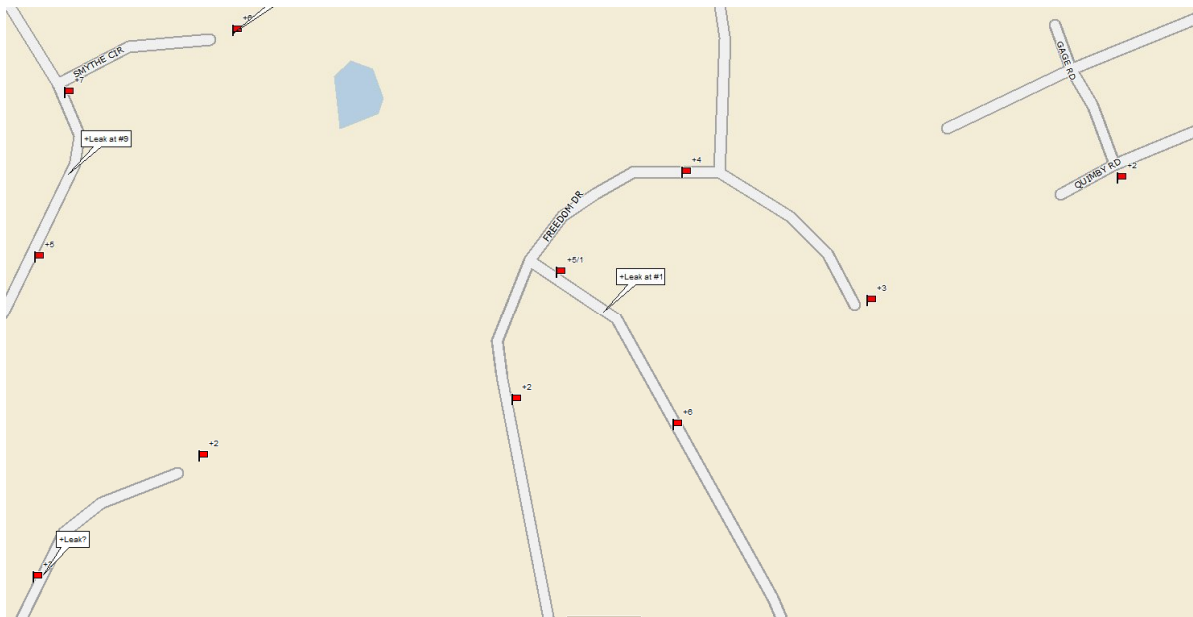
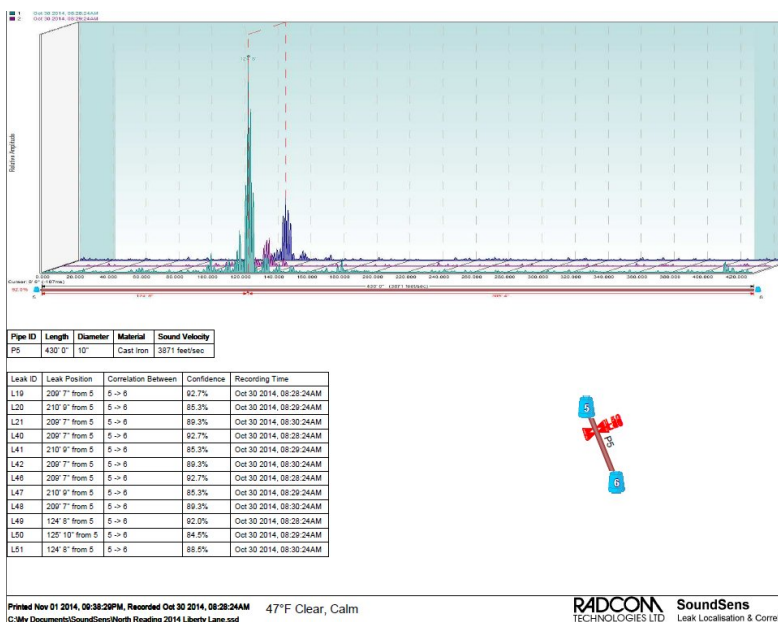
Location: 1 Liberty Lane, Service Leaking, Need to expose curbstop using as-built; cannot locate with metal detector

Approx. Size: Unknown

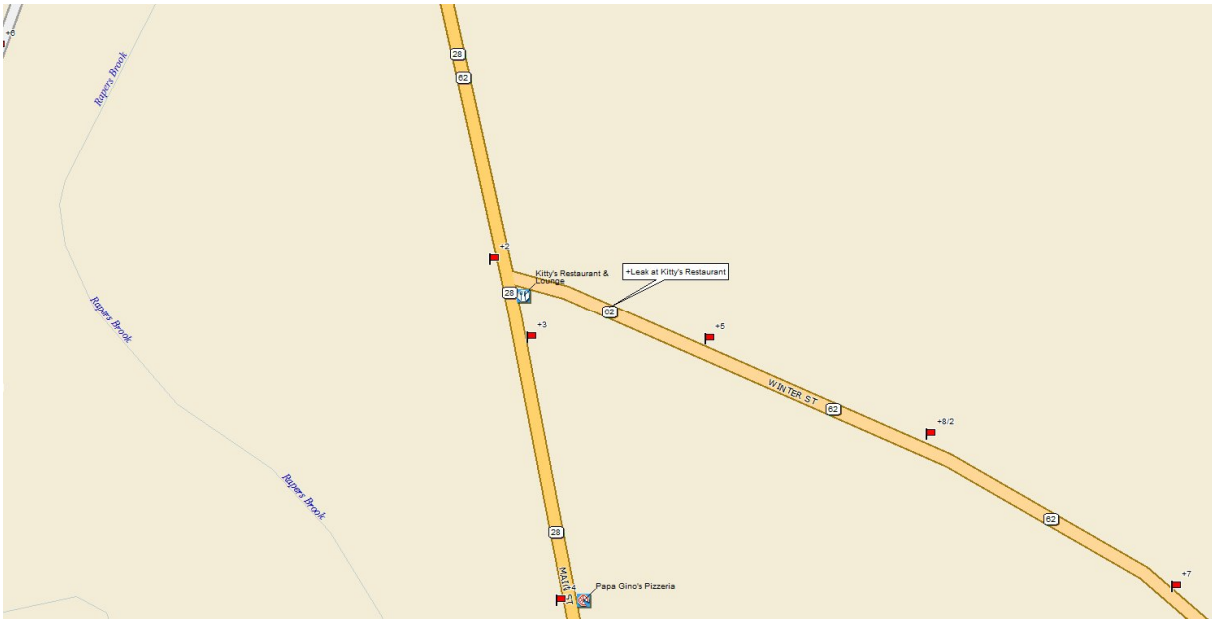
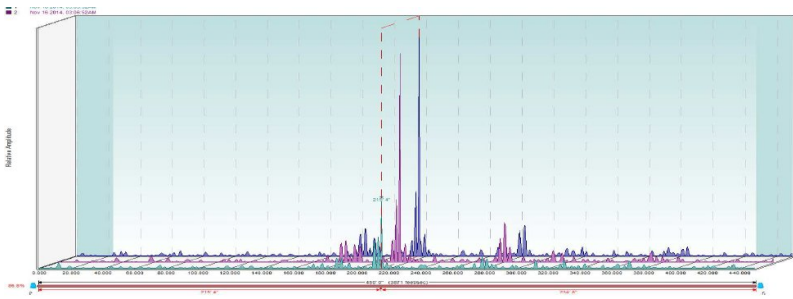
System Name: Town of North Reading, Massachusetts  
Department of Public Works, Water Department  
Location: Kitty's Restaurant Fire Service Leaking  
Approx. Size: 2-4 GPM  
Weather: 25°F Clear, Calm  
Date and time of detection on correlation: 11/16/2014 3:05 AM

Pipe ID	Length	Diameter	Material	Sound Velocity
P2	450' 0"	10"	Cast Iron	3871 feet/sec

Leak ID	Leak Position	Correlation Between	Confidence	Recording Time
L7	215' 4" from 2	2 -> 5	98.8%	Nov 16 2014, 03:05:52AM
L8	215' 4" from 2	2 -> 5	90.9%	Nov 16 2014, 03:06:52AM
L9	215' 4" from 2	2 -> 5	90.9%	Nov 16 2014, 03:07:52AM
L10	149' 9" from 5	5 -> 3	80.7%	Nov 16 2014, 03:05:52AM
L11	149' 9" from 5	5 -> 3	82.1%	Nov 16 2014, 03:06:52AM
L12	263' 8" from 5	5 -> 3	80.0%	Nov 16 2014, 03:07:52AM
L19	215' 4" from 2	2 -> 5	90.6%	Nov 16 2014, 03:06:52AM
L20	215' 4" from 2	2 -> 5	90.9%	Nov 16 2014, 03:07:52AM

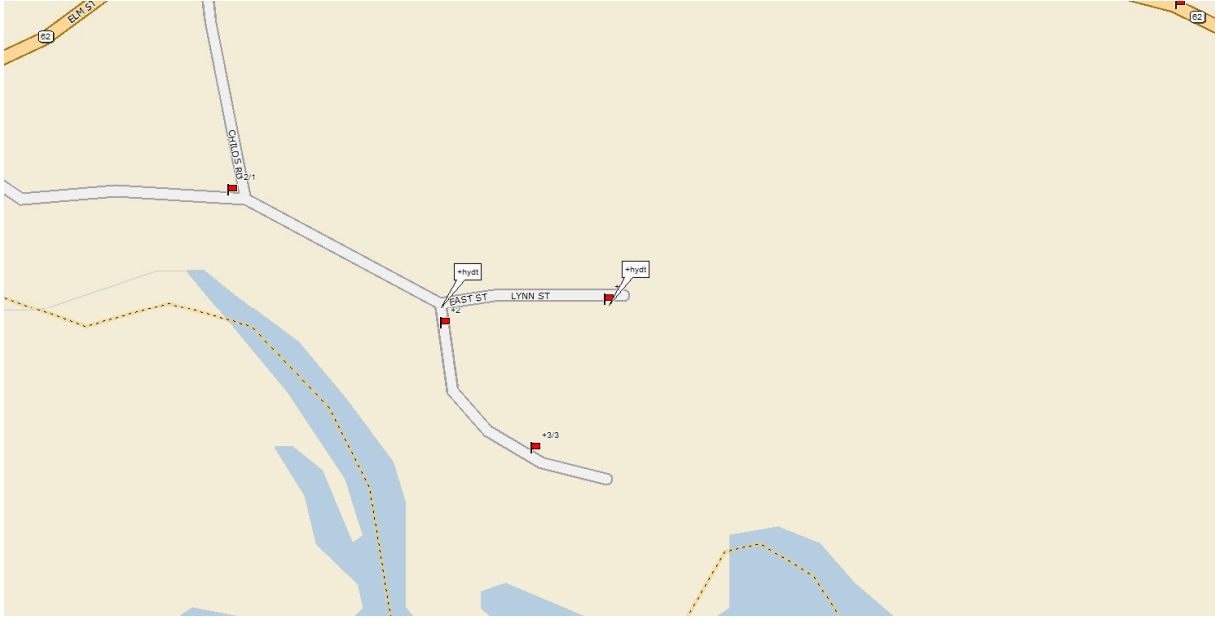
**System Name:** Town of North Reading, Massachusetts  
**Department of Public Works, Water Department**  
**Location:** Hydrant across from 7 East Street  
**Approx. Size:** 1-2 GPM  
**Weather:** 55°F Scattered Clouds, 8MPH Wind  
**Date and time of detection:** 10/10/2014 10:05 AM

Leak detected during the audit of noise logger recordings. No correlations available. Located using ground microphone.

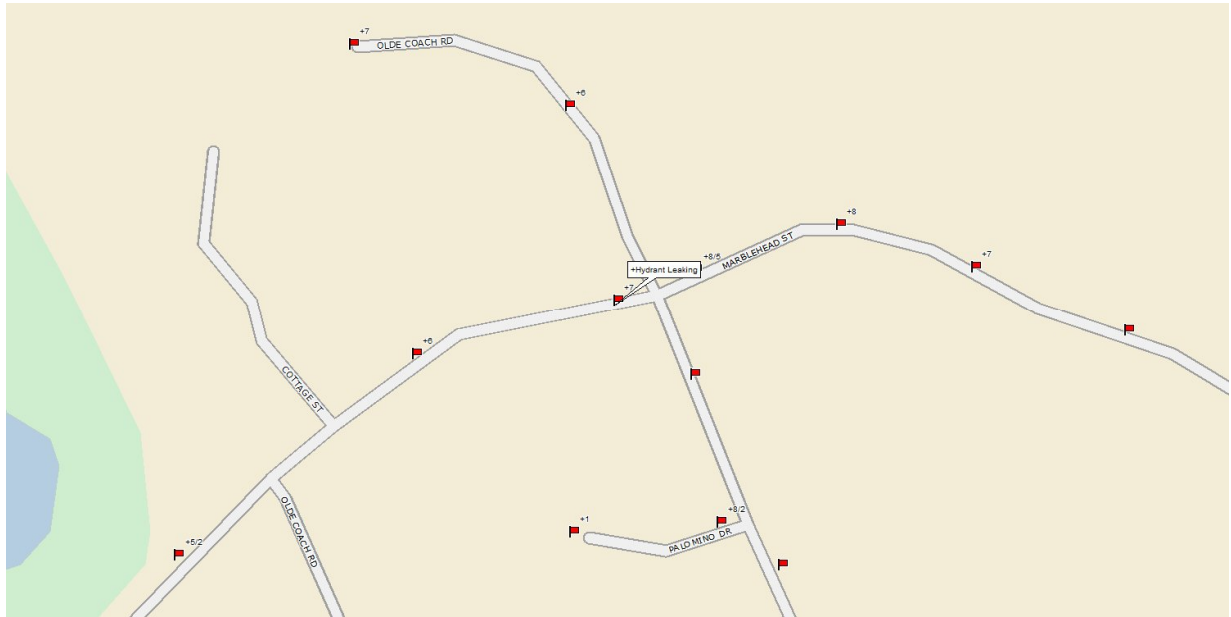
**System Name:** Town of North Reading, Massachusetts

Leak detected during the audit of noise logger recordings. No correlations available. Located using ground microphone.

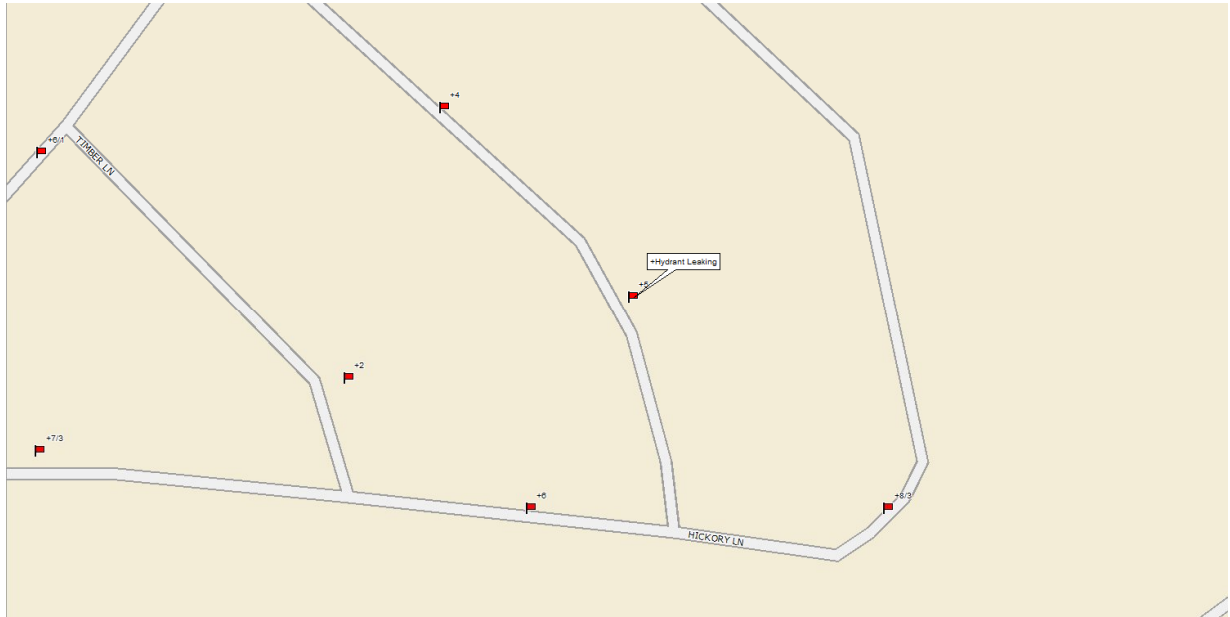
System Name: Town of North Reading, Massachusetts

Leak detected during the audit of noise logger recordings. No correlations available. Located using ground microphone.

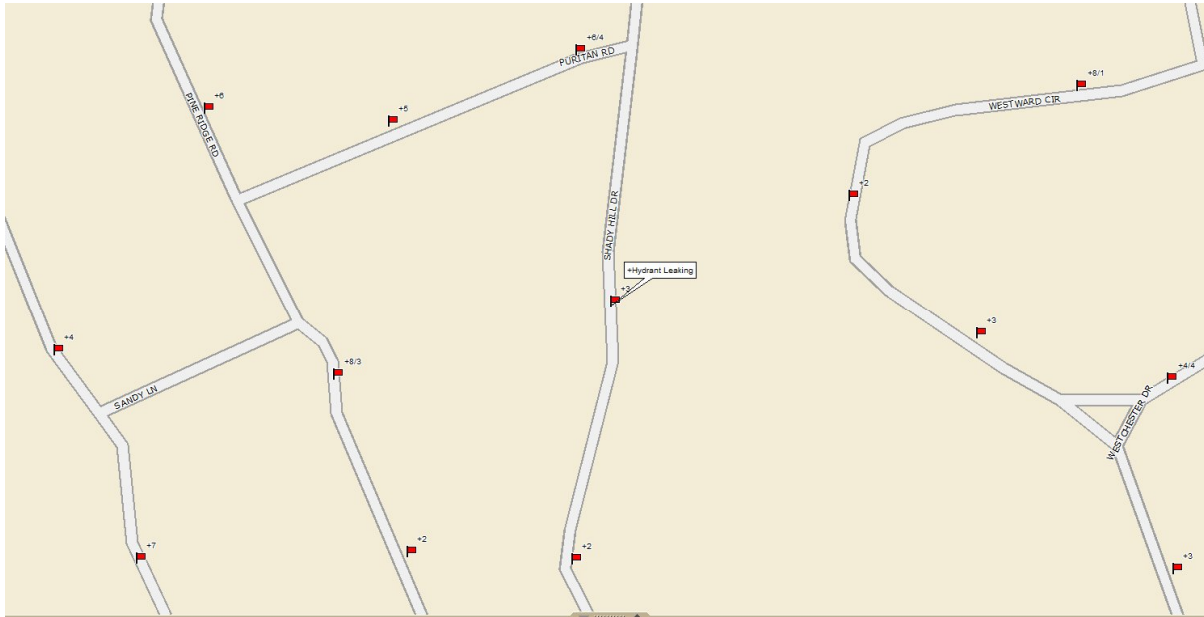
**System Name:** Town of North Reading, Massachusetts  
**Department of Public Works, Water Department**  
**Location:** Hydrant by 19 Shady Hill Drive  
**Approx. Size:** ½-1 GPM  
**Weather:** 54°F Mostly Cloudy, 10 MPH Wind  
**Date and time of detection:** 10/28/2014 9:53 AM

Leak detected during the audit of noise logger recordings. No correlations available. Located using ground microphone.

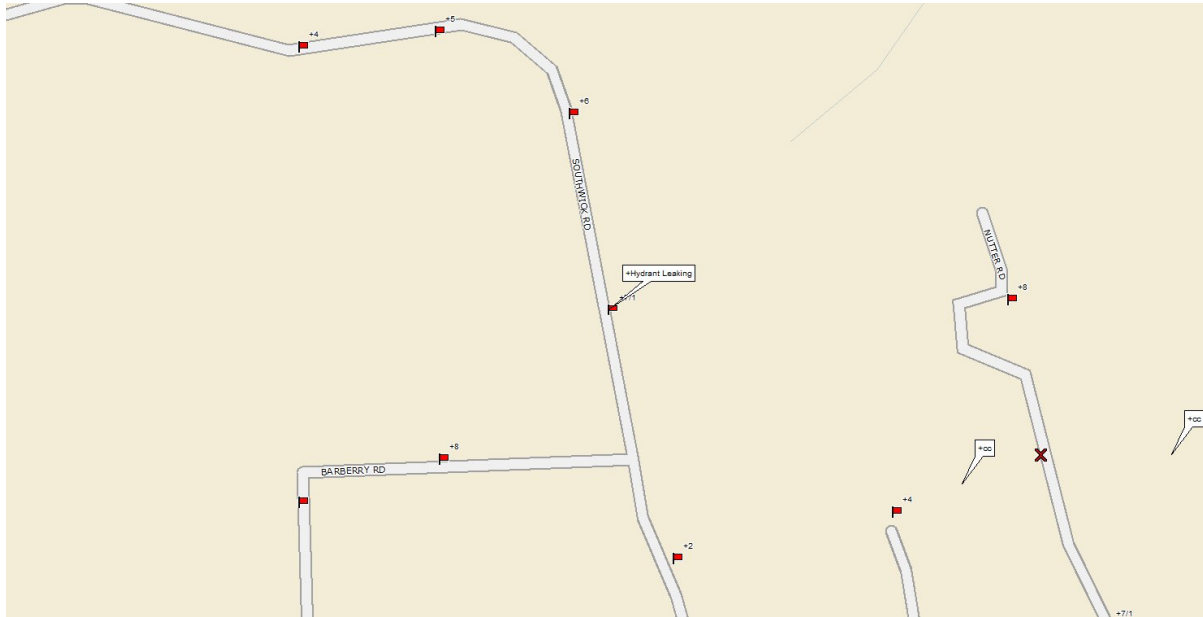
System Name: Town of North Reading, Massachusetts

Leak detected during the audit of noise logger recordings. No correlations available. Located using ground microphone.

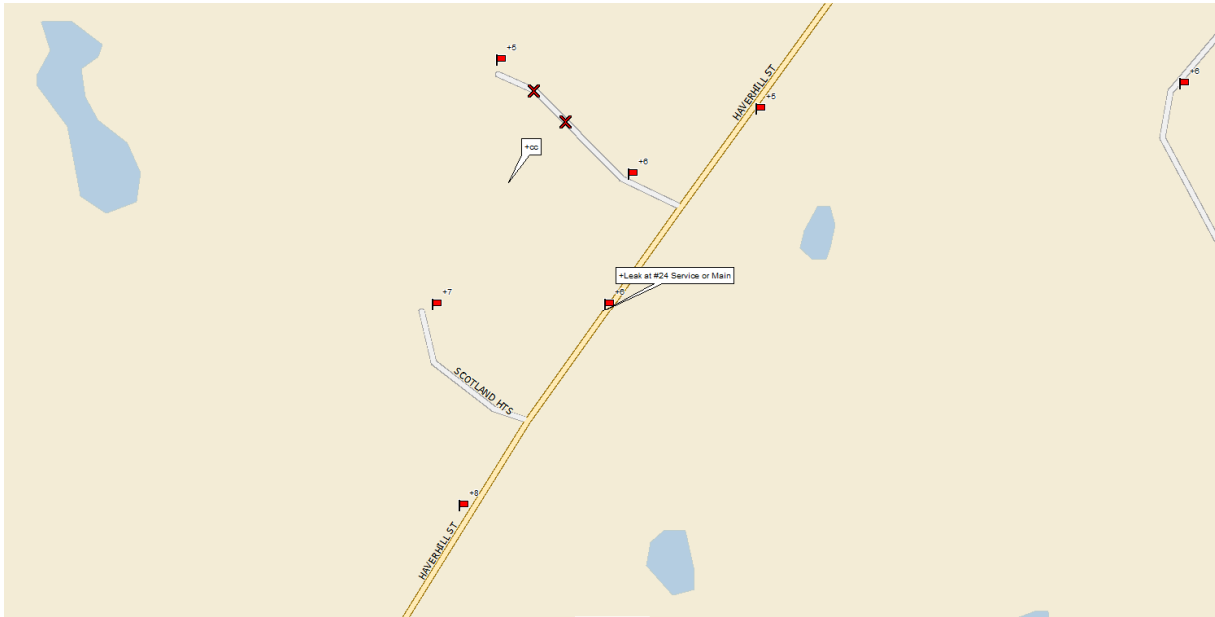
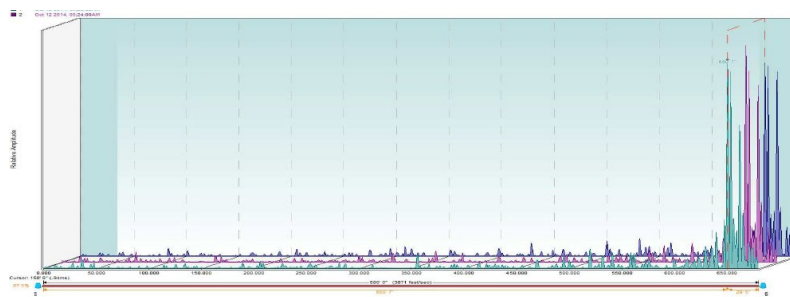
**System Name:** Town of North Reading, Massachusetts  
**Department of Public Works, Water Department**  
**Location:** Service or main leak by 24 Haverhill Street  
**Approx. Size:** 1-2 GPM  
**Weather:** 37°F Clear, 6MPH Wind  
**Date and time of detection on correlation:** 10/12/2014 5:23 AM

Pipe ID	Length	Diameter	Material	Sound Velocity
P5	650' 0"	10"	Cast Iron	3871 feet/sec

Leak ID	Leak Position	Correlation Between	Confidence	Recording Time
L19	650' 7" from 5	5 -> 6	87.5%	Oct 12 2014, 05:23:00AM
L20	650' 7" from 5	5 -> 6	88.0%	Oct 12 2014, 05:24:00AM
L21	650' 7" from 5	5 -> 6	87.8%	Oct 12 2014, 05:25:00AM
L37	650' 7" from 5	5 -> 6	88.0%	Oct 12 2014, 05:26:00AM
L38	650' 7" from 5	5 -> 6	87.4%	Oct 12 2014, 05:26:00AM
