Town of North Reading Massachusetts  
Department of Public Works  
Water Department

Water System Leak Detection Survey Report  
2014

Arthur Pyburn & Sons Inc.

The following is a summary of leak detection performed on 80 miles of the North Reading Water Department's distribution system.

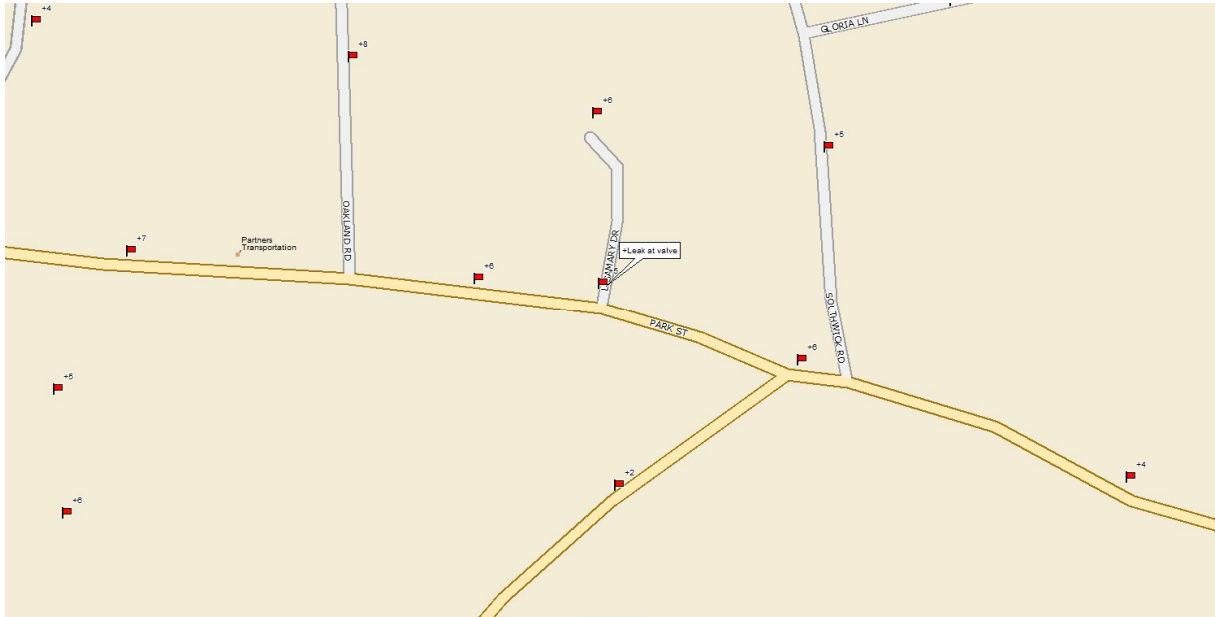
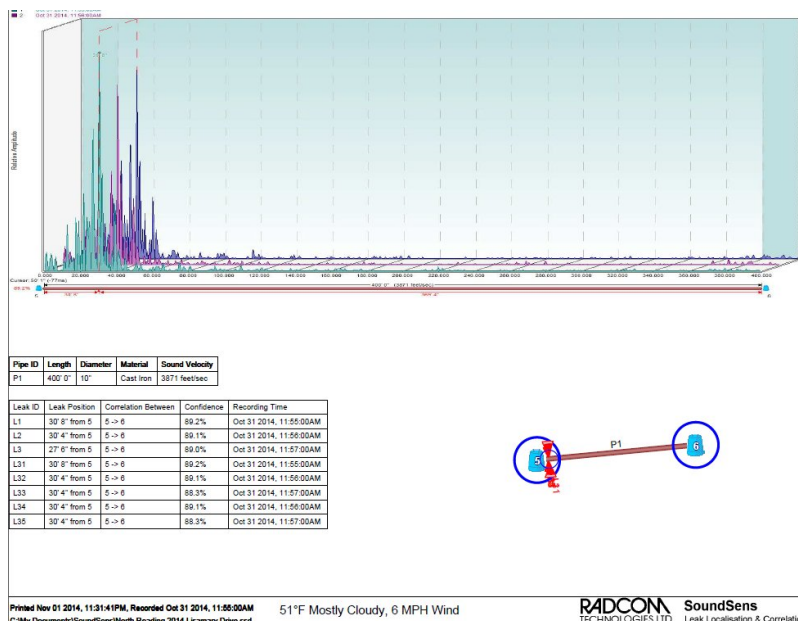
System Name: Town of North Reading, Massachusetts  
Department of Public Works, Water Department  
Location: Believed to be a mechanical joint on valve for Lisamary Drive  
Approx. Size: 4-8 GPM  
Weather: 51°F Mostly Cloudy, 6 MPH Wind  
Date and time of detection on correlation: 10/31/2014 11:55 AM
