INTRODUCTION and EXECUTIVE SUMMARY

WaterTech International has been retained by the Town of North Reading, Massachusetts, to conduct an assessment of water conservation opportunities for some of the town's municipal buildings and schools. The assessment was conducted under the oversight of North Reading's Department of Public Works Superintendent, Mr. Richard Carnevale.

Selected Building Profiles, Description
&
Water Conservation Opportunities
&
Recommendations

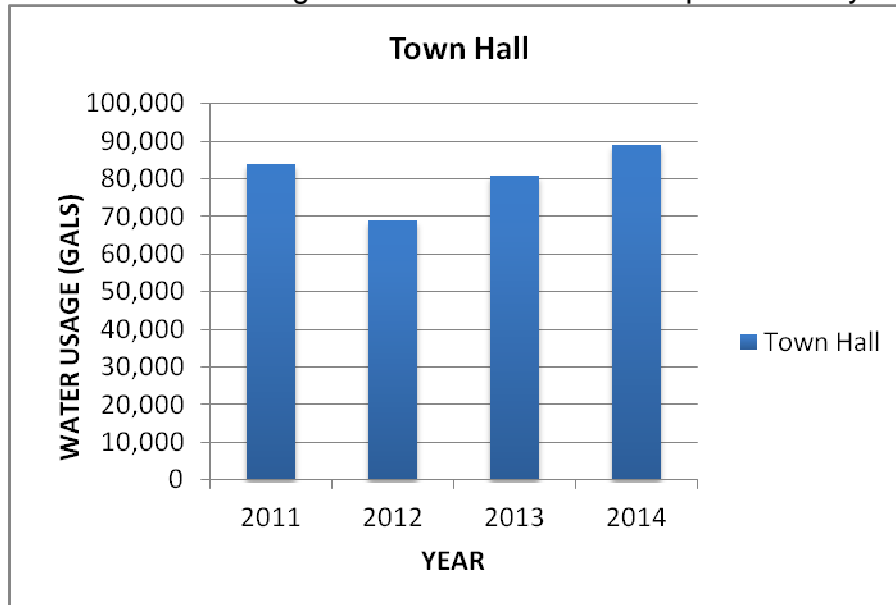
Figure "A"
North Reading Town Hall Water Consumption History

Recently, in an attempt to meter water consumption more accurately, the incoming water meter was significantly reduced in size to reduce the amount of inaccuracies in the readings.

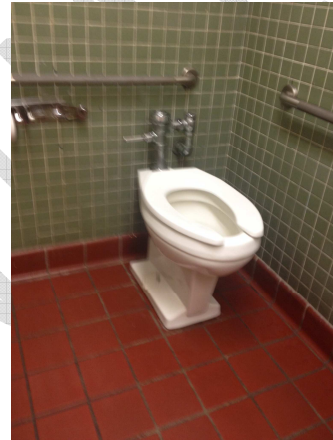
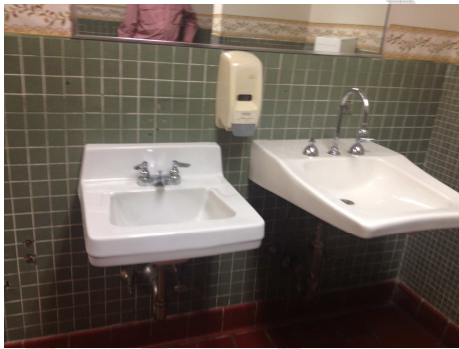
The toilets were found to all be floor mounted /floor outlet flushvalve operated toilets.

The sinks in the Men’s and Ladies restrooms are equipped with standard 3-gpm aerators. All sink aerators in the lobby restrooms have been tampered with and are missing screens. We recommend that installation on tamper resistant 0.5 gpm aerators.

By installing new tamper resistant 0.5-gpm laminar flow aerators on the new faucets, a significant reduction can be made in the amount of water used.

The installation of the new laminar flow aerators will produce a more precise and shower type flow pattern, washing quality will not be reduced. Water flow will be cut by 80% without increasing washing time.

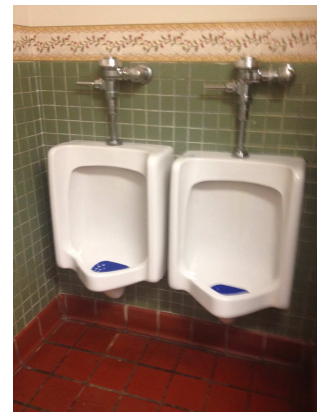
The urinal valve body flow rates were also found to be turned down to a very small flow, though-out the town’s building as well.

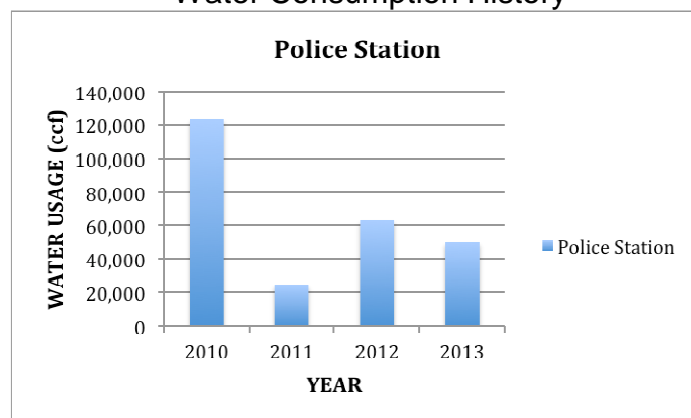
Figure "A"
Water Consumption History

Since the fiscal year 2010, water consumption at the police department significantly dropped for a year then spiked at just over 63,000 CCF in 2012. Here it then remained rather steadily around 50,000 CCF for the next year.

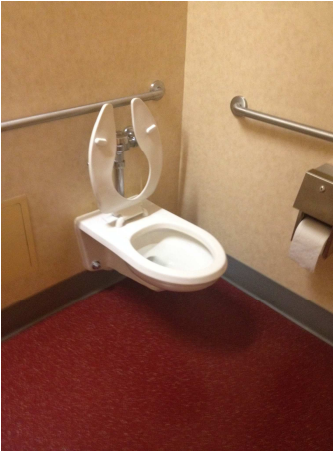
The public restrooms located off the lobby of the station are relatively new. The toilets are 1.6-gpf or less fixtures, but strangely the flushvalves are not new but reused 3.5 valve bodies with 1.6-gpf retrofit inserts. A similar situation is present in the women's room near-by.

Public use of the lobby Men's and Women's rooms is moderate. Fixtures in both rooms are similar. Toilets use 1.6 gpf units,

By replacing the existing mismatched flush valves, the toilet will be able to flush at its intended design flow rates.

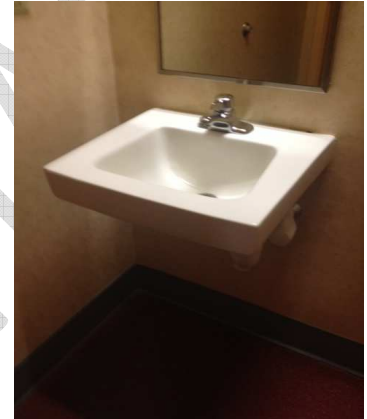
Sinks are also new and have 0.5-gpm aerators already installed. No recommendations are made for the sink aerators. In the police station

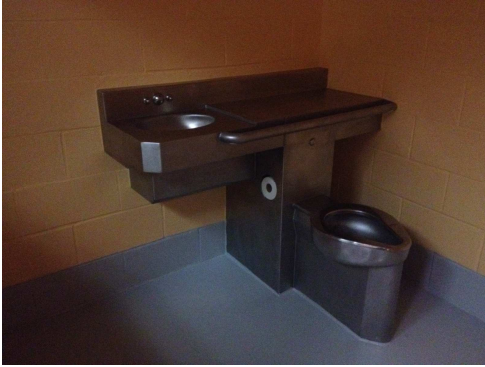
Lock-up (No Recommendations)

The lock-up area in the lower floors houses Men, Women and if the need arises, even Juveniles.

All fixtures in the cells are designed to correctional institutional standards. There are no recommendations that can be offered for the lock-up area.

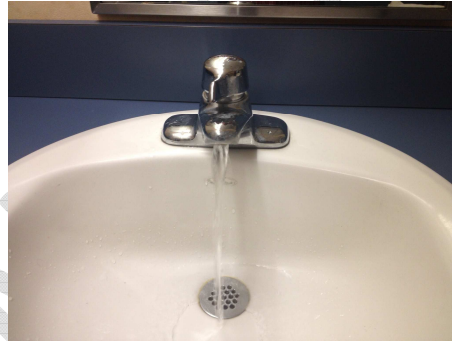
The building has two restrooms, one for the first floor lobby area, and the other on the second floor of the commons area. The 1st floor bathroom has one 3.5 gpf toilet, and a sink with a low flow measuring less than 1-gpm.

The building has a total of 3 toilets, one located on the main floor and 2 on the second floor housing area. The restrooms located on the main floor are located in the dispatch room by the main truck bay. The truck bay bathroom is used on occasions by outside visitors but that has become very infrequent.

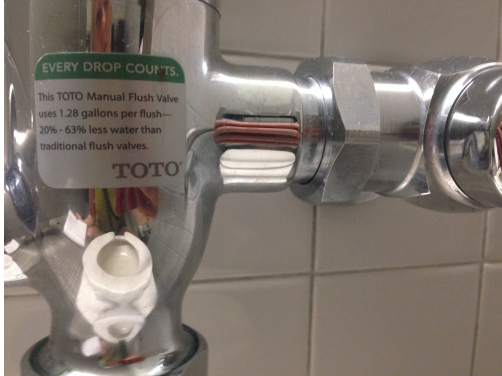
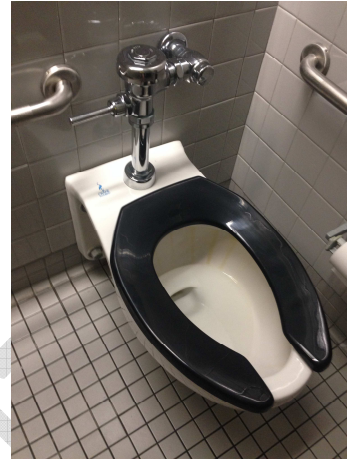
All, of the toilets are wall mounted, wall outlet units. The estimated consumption is 3.5 gallons per flush. Most of the flushometers are manually activated; there are also a few 1.28 gpf Toto flushometers on the old 3.5-gpm bowls.

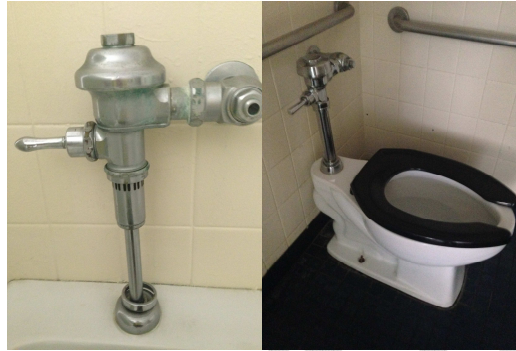
Figure A. Example of typical restroom toilet and flush valve. Many of the toilets are equipped with very old flushometers.

Both the toilets and urinal fixtures were found to be of pre-75 vintage and most likely date back to the time the Elementary School was built. The fixtures are large water consumers and are good candidates for a replacement program.

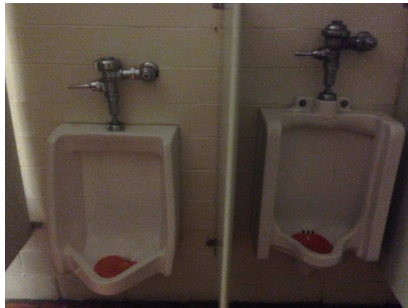
The urinals in the building were mostly older units with replacement of some flush valves.

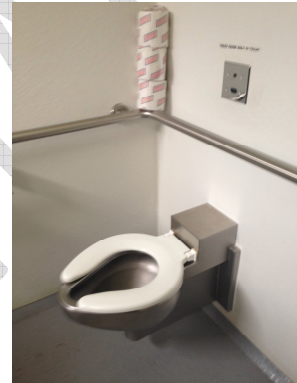
The facilities located at the Ipswich River Park are equipped with Stainless steel institutional type toilets and sinks. The toilets are equipped with behind the wall automatic sensor flushometers, and stainless steel sinks with 0.5 gpm aerators.
